Wainfleet Library and Fire Station No. 2

Condition Assessment – 2015

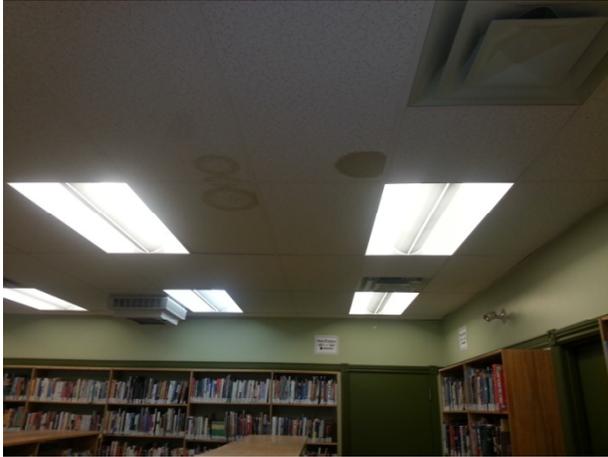
- The structure of the community wall was not visible except the load bearing concrete block walls. The roof structure is unknown,
- The library ceiling exhibits many water stains, presumably from roof leaks. These should be reviewed,

Photo 13 - Library ceiling water stains

The building appeared to be in good condition with only a few maintenance /remedial works required. Inspection of the roof should review the source of the leaks and make repairs

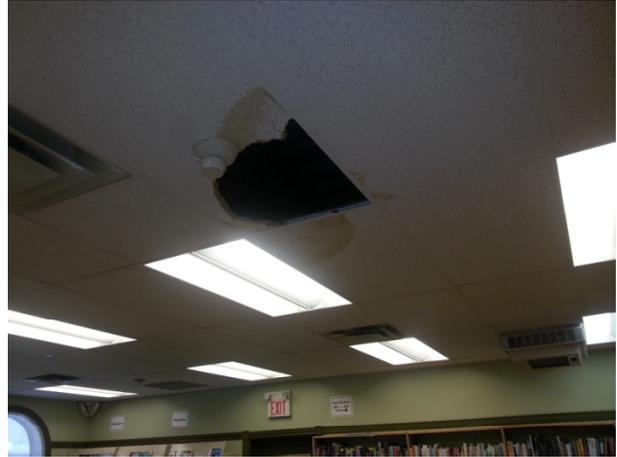
Photo 14 - Library ceiling water stains

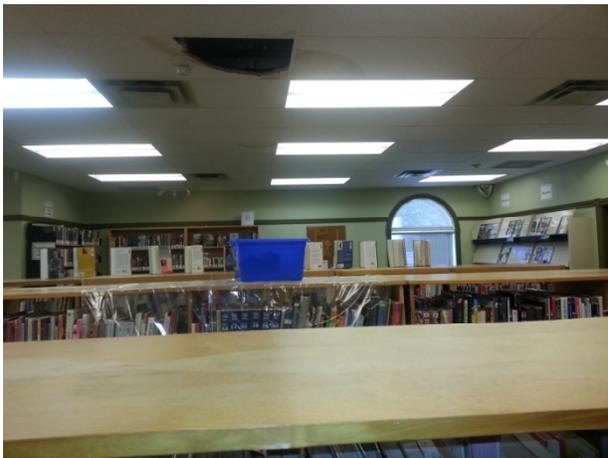
Photo 15 - Library ceiling water stains

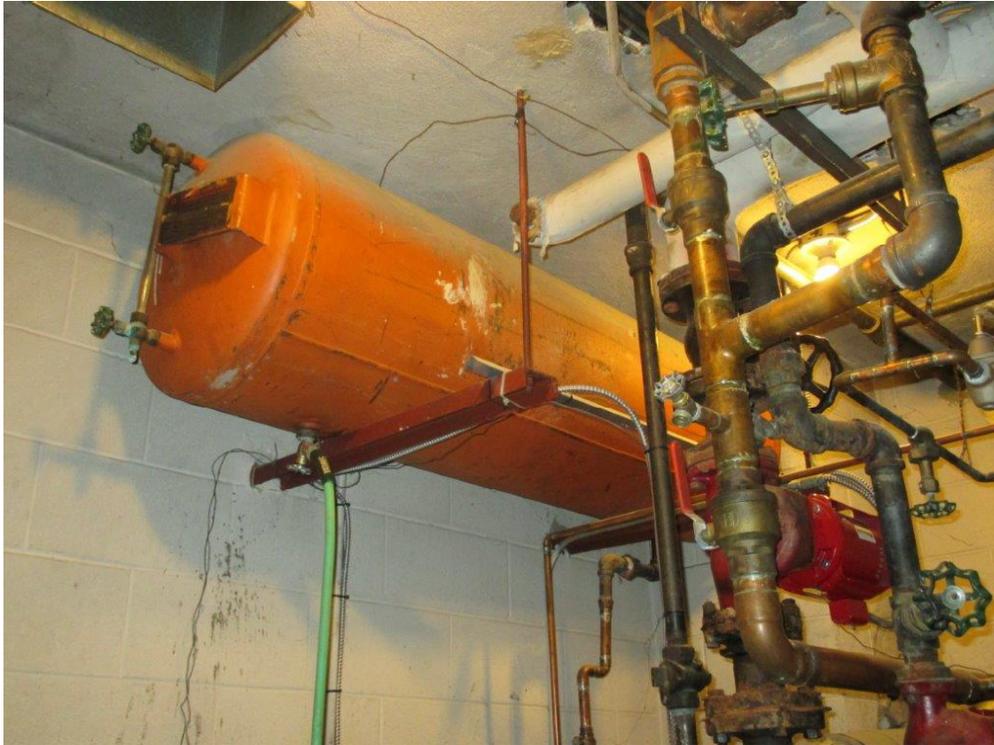
The boiler system (boiler, pumps, piping, expansion tank, etc.) appear original and in poor condition (P3, P14, P17).

P3 – Uninsulated heating piping, boiler system piping

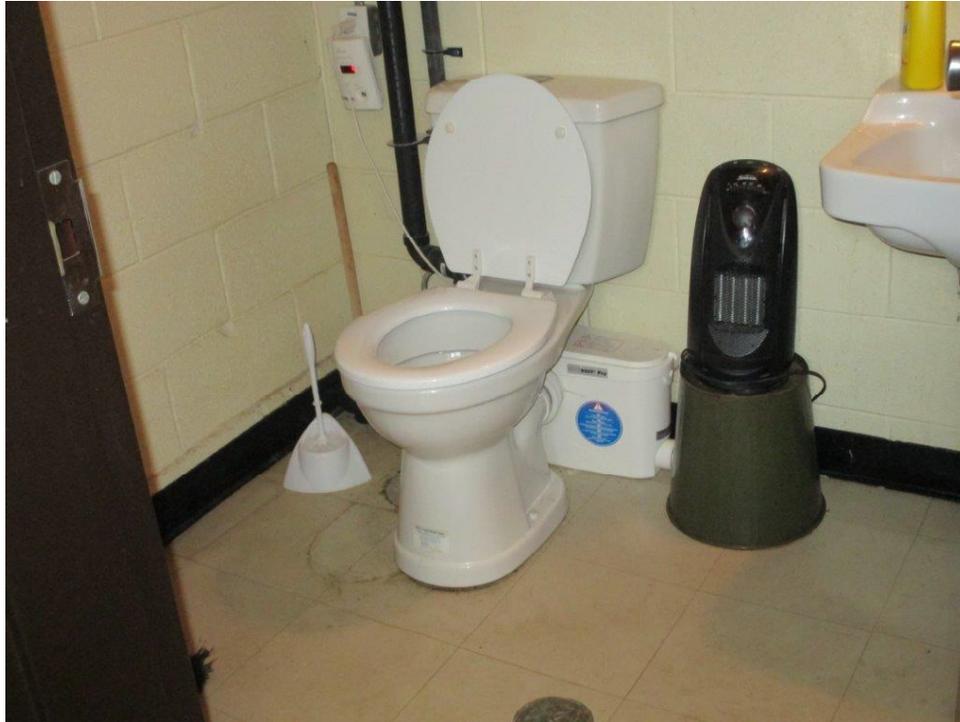
The EMS office has a macerating toilet (P9). Town staff noted that there has been a drainage problem from the standard water closet that was previously in this office. The problem could not be cleared so this alternate toilet/pump was installed.

P9 – EMS macerating water closet

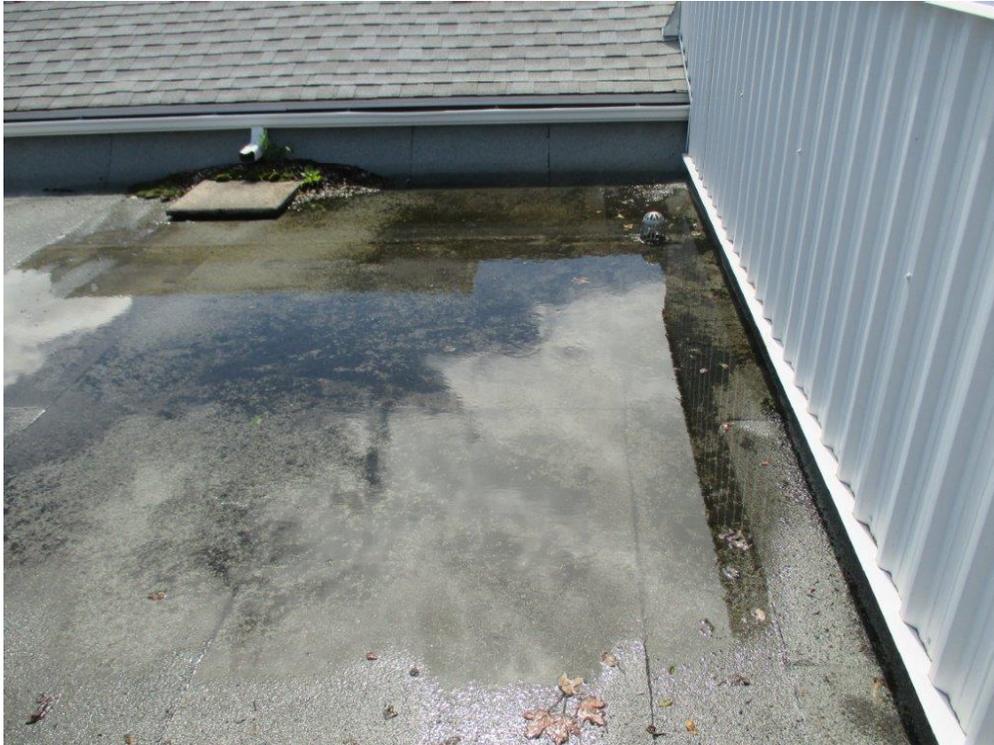
P11 – Roof ponding

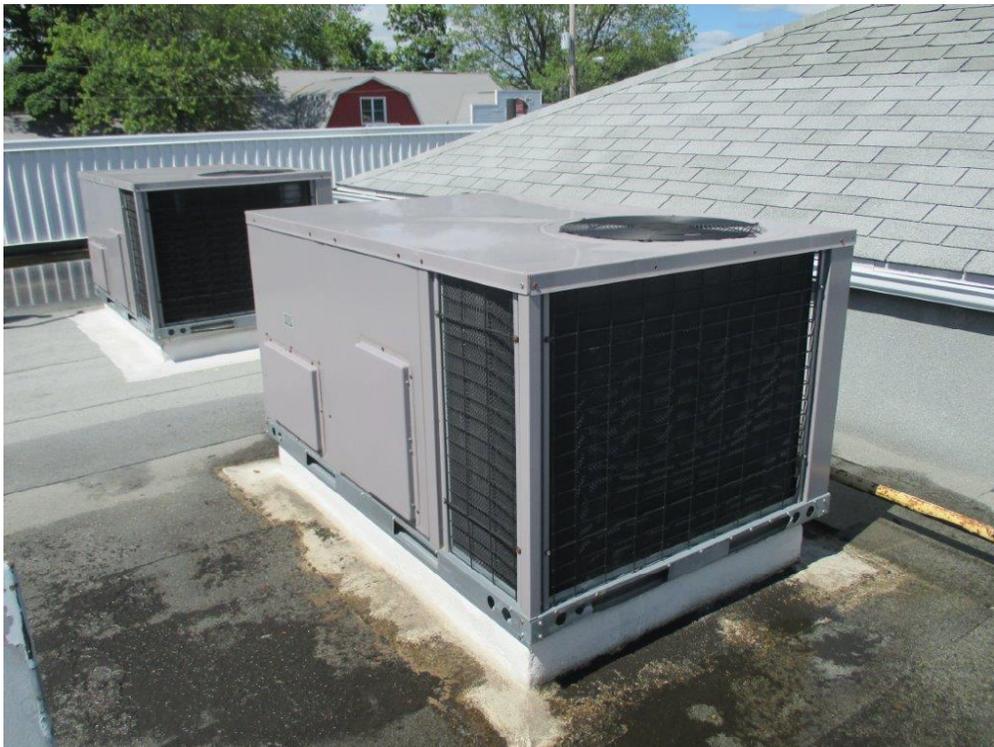
Air conditioning is provided with two (2) packaged gas heat/electric cooling rooftop units (P12). The units are in fair condition, original equipment when the library was constructed. Neither rooftop unit has a fresh air damper for ventilation to the space. This is contrary to the Ontario Building Code. The air system recirculates the air only. No outdoor air is brought into the space. The two units also do not have an economizer that would allow free cooling when the outside air temperature is cooler than the space. Much energy can be saved during cooling times when the mechanical cooling does not have to run in lieu of opening the economizer damper and bring in cooler outdoor air entirely.

P12 – HVAC unit without dampers

- .1 Renovate the rooftop Library HVAC units to provide outdoor air dampers and economizers for fresh air to space and free cooling.
- .2 Expand boiler system to Library and remove electric heat.
- .3 Ventilate the Library Storage Room.
- .4 Provide CO/NO₂ detection system in Fire Hall to operate ventilation system.
- .5 Provide ventilation system for Fire Truck Bay.
- .6 Provide furnace/ventilation system for Fire Hall Lounge and EMS Office.
- .7 Replace/upgrade the boiler system and expand it to the Library.
- .8 Insulate all the heating piping.
- .9 Provide gas to community center HVAC units to allow winter heat and ventilation.
- .10 Replace the existing kitchen hood exhaust system and provide NFPA exhaust hoods, ducts & exhaust fan, and make up air systems.

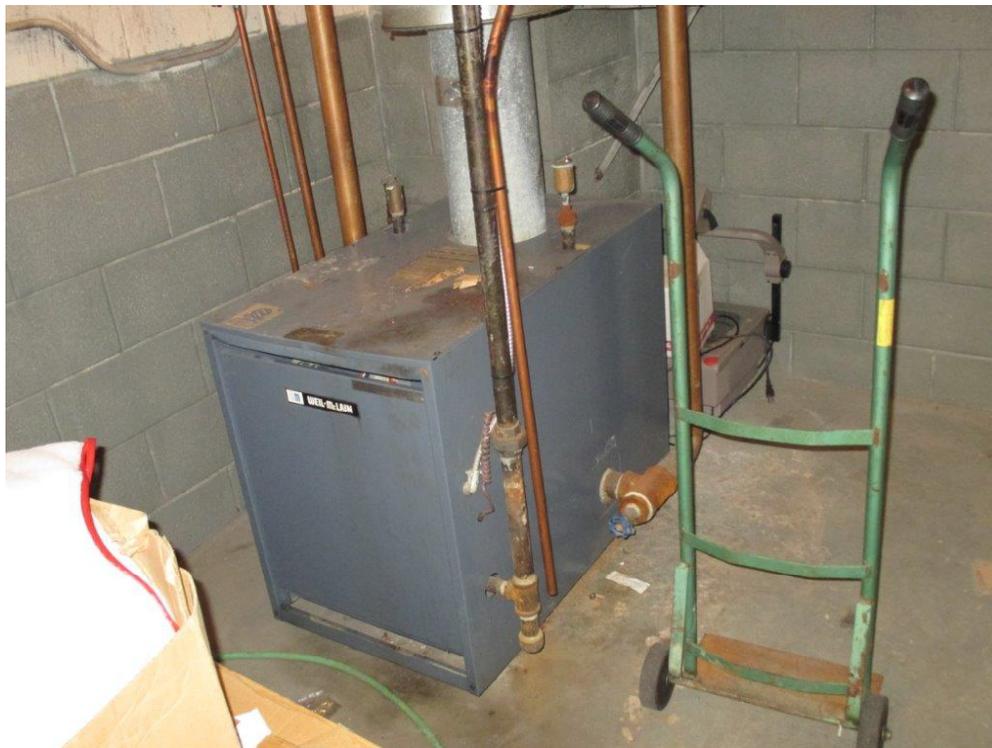
P14 – Boiler

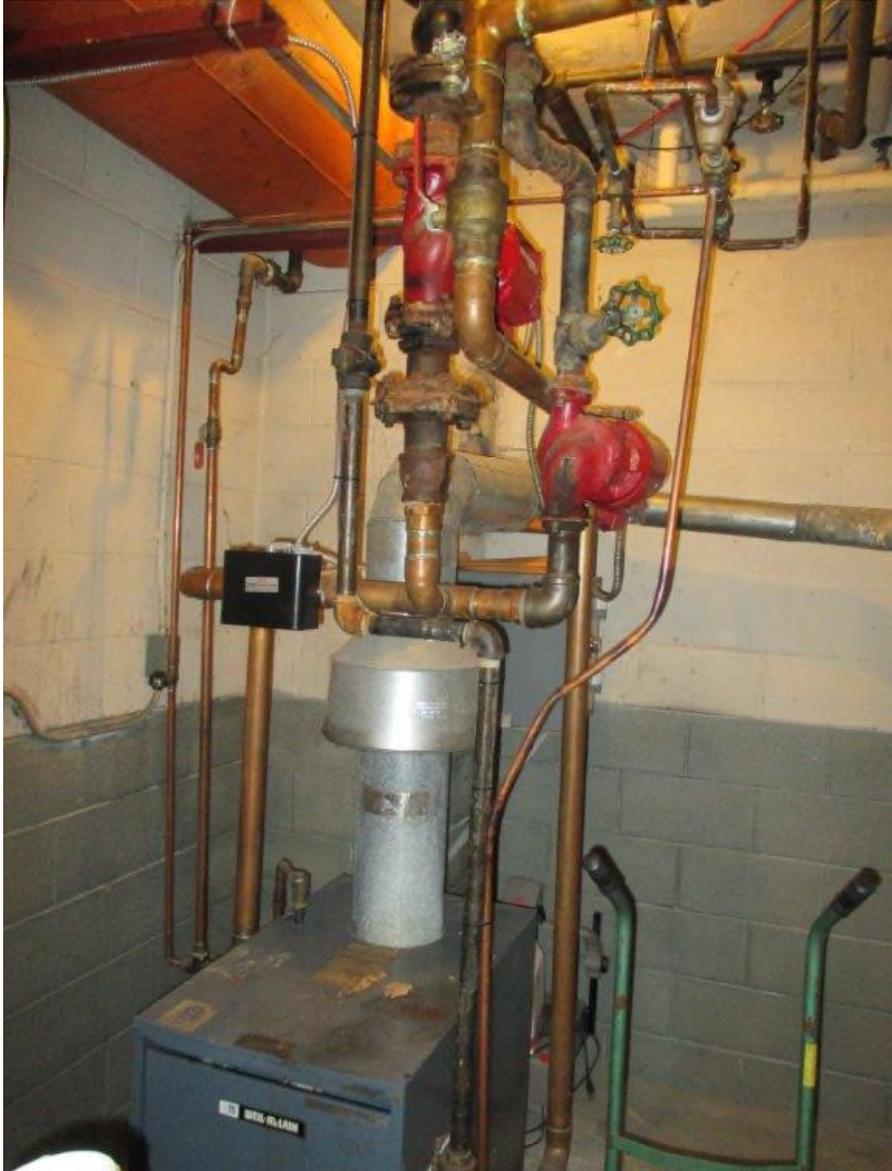
P17 – Boiler piping system

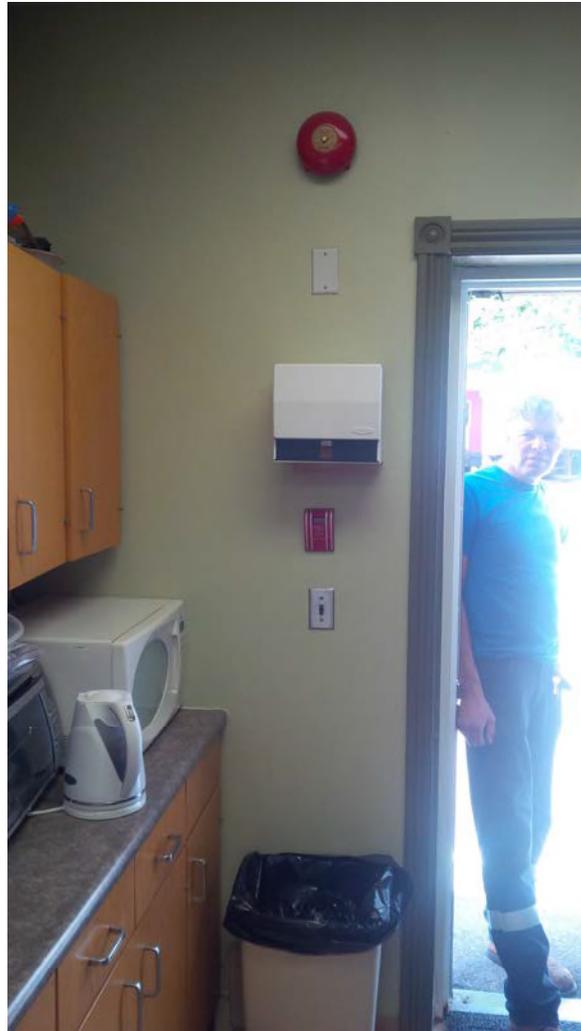
P16 – Library fire alarm device mounted too high

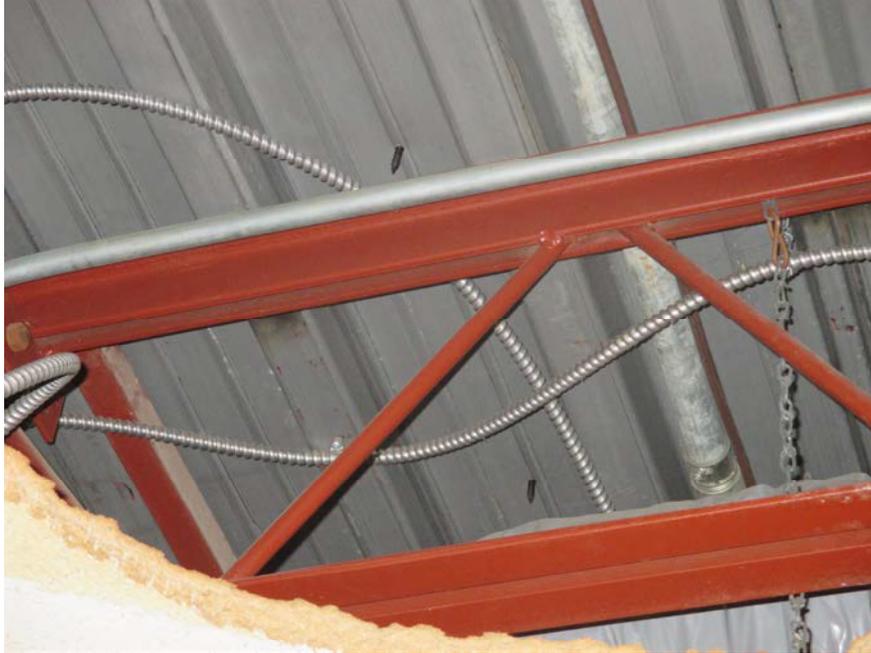
P17 – Unsupported AC90 cable

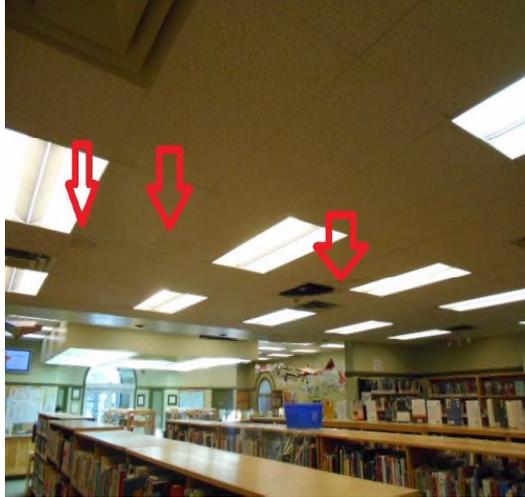
Photo 2

Red arrows indicate areas of water leakage in back room and main library.

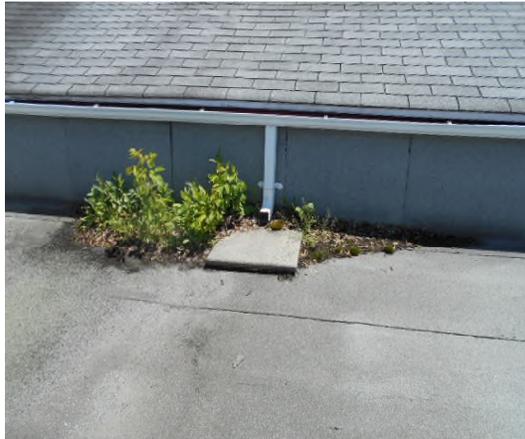
Photo 4

Drain screen missing from drain on lower roof. Vegetation of roof beside paver.

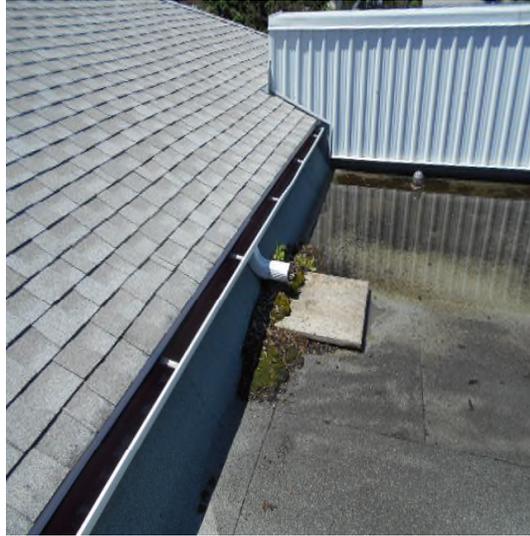
Photo 8

Ponding water was observed at numerous locations on this small roof area.

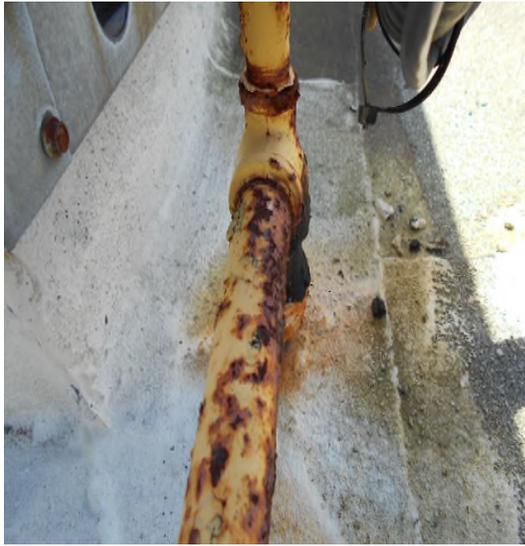
Photo 14

- C.A.B.S Inc. observed that the gas line to the roof top units is rusting. (Photos 13 & 14)
- The proper gum boxes were not used for the electrical services for the rooftop unit and we noted that where the wire protrudes through the caulking at the flex wire there is a substantial hole which would allow for water infiltration. (Photos 15 & 16)

Rusting gas lines can become problematic if not addressed.

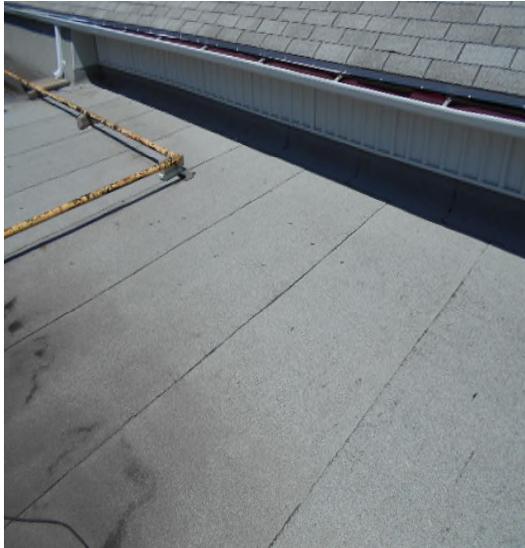
Photo 18

- It was observed that the flat roof at the location where the reshingling on the lower EMS portion was done, was riddled with roofing nails which, if stepped on could conceivably puncture the roof membrane. (Photo 18)

Sealant is failing on collar. The roof membrane is littered with roofing nails from the reshingling of the lower part over the EMS area.

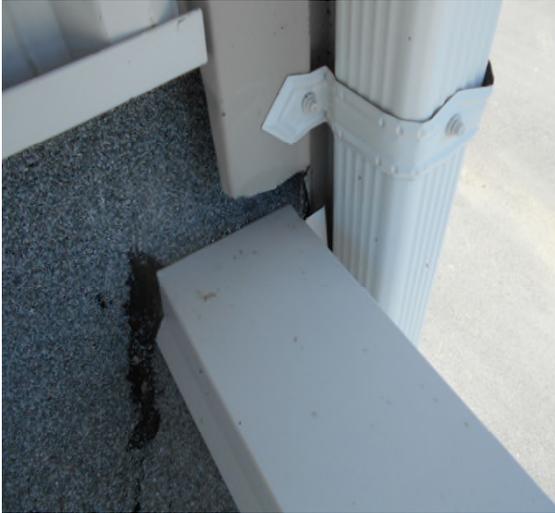
Photo 19

- It was noted that the Styrofoam underneath the sleepers for the gas line has deteriorated from the UV rays of the sun.
- The metal cap flashing at the back of the tie-in to the wall for the EMS has no sealant on the cap flashing. (Photo 19)

No sealant at flashing termination on parapet wall tie in.

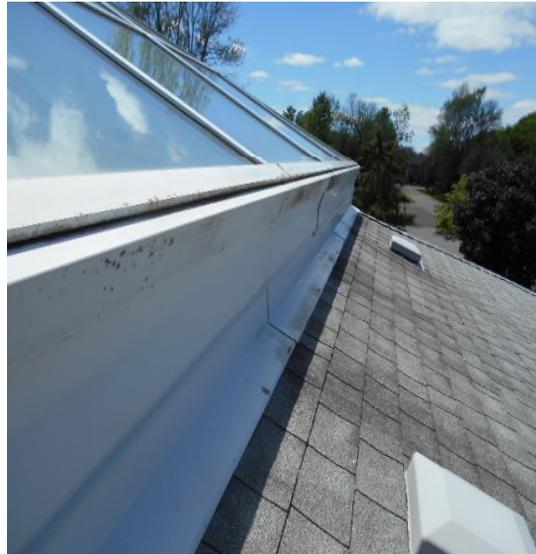
Photo 2

- The metal flashing seals on the corners of the skylight have failed and could allow a wind driven rain access into and behind the roof assembly.
- C.A.B.S Inc. noted that the sealant on the skylight has sheared from the flashing to the cap flashing on the skylight. (Photos 1 – 3)

Sealant on flashings of skylight is failing at corner. Sealant also inconsistent on skylight units.

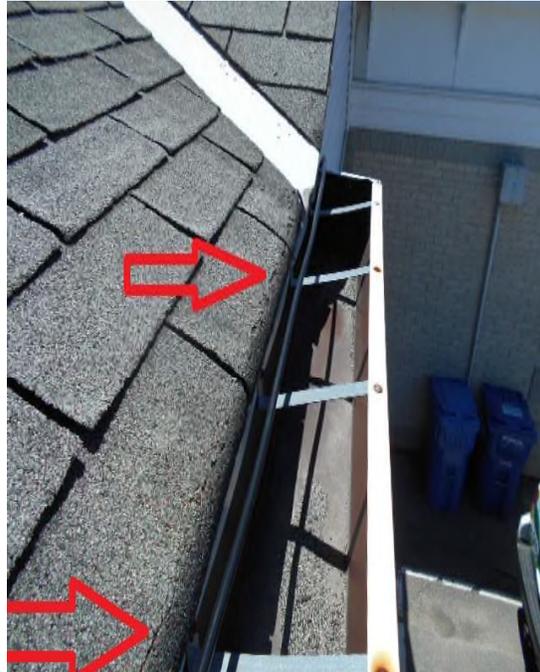
Photo2

Upper commercial eavestrough drains through PVC pipe into residential trough above overhead doors. Shingles have been bent at eaves and are cracking.

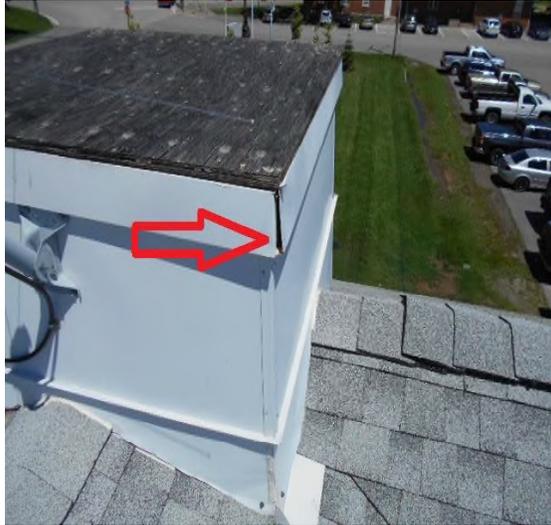
Photo 8

Sealant at base is failing. Exposed plywood cap is deteriorating. Wasps were seen nesting at open end of flashing.

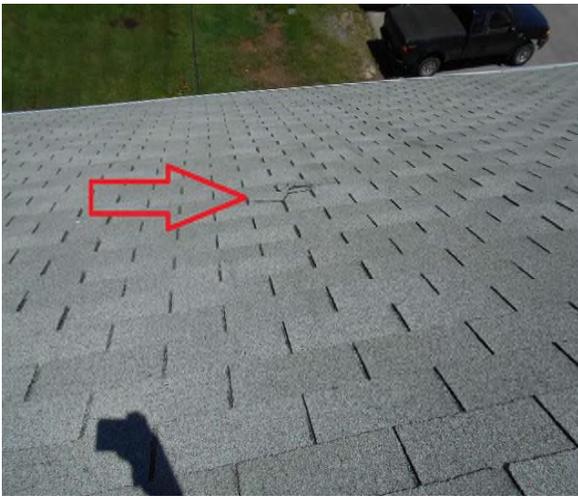
Photo 10

Broken shingle is seen at arrow.

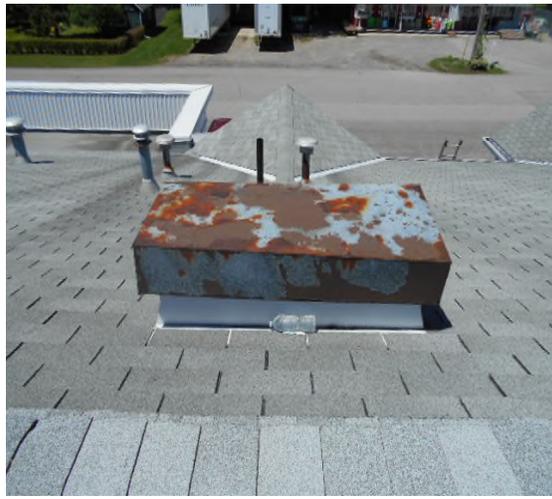
Metal cap is rusting.

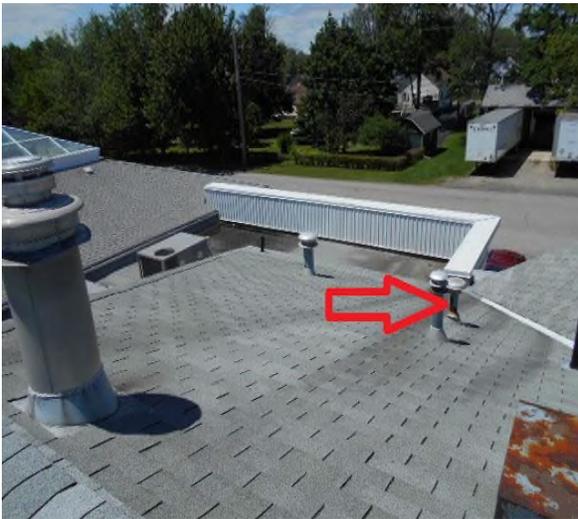
Photo 11

Chimney is starting to rust. Sealant on collar is failing. Rust on flange at nail. Shingle lifting at ridge.

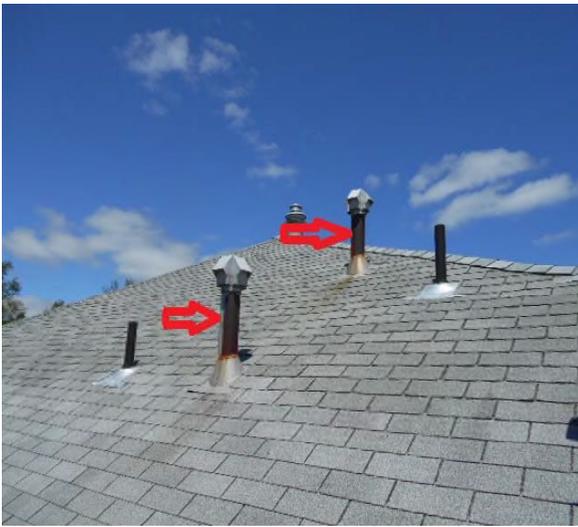
Chimneys are rusting out.

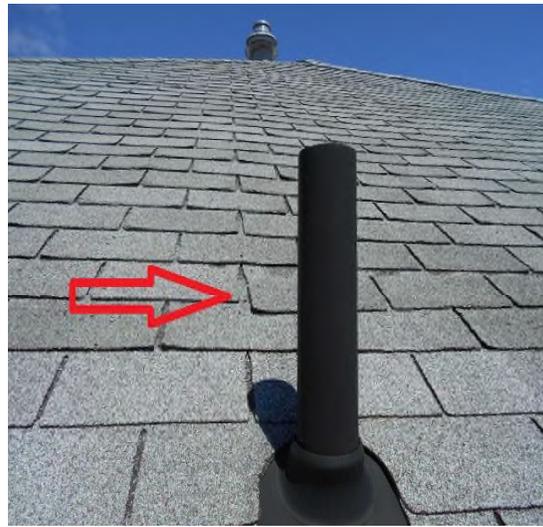
Shingle is loose above vent stack.
