## **ARBORIST REPORT**

10165 Cedar Crest Road  
Port Colborne, Ontario  
L3K 5V4

Version: 1.0 - February 27th 2026

# Tree Preservation Plan (TPP)

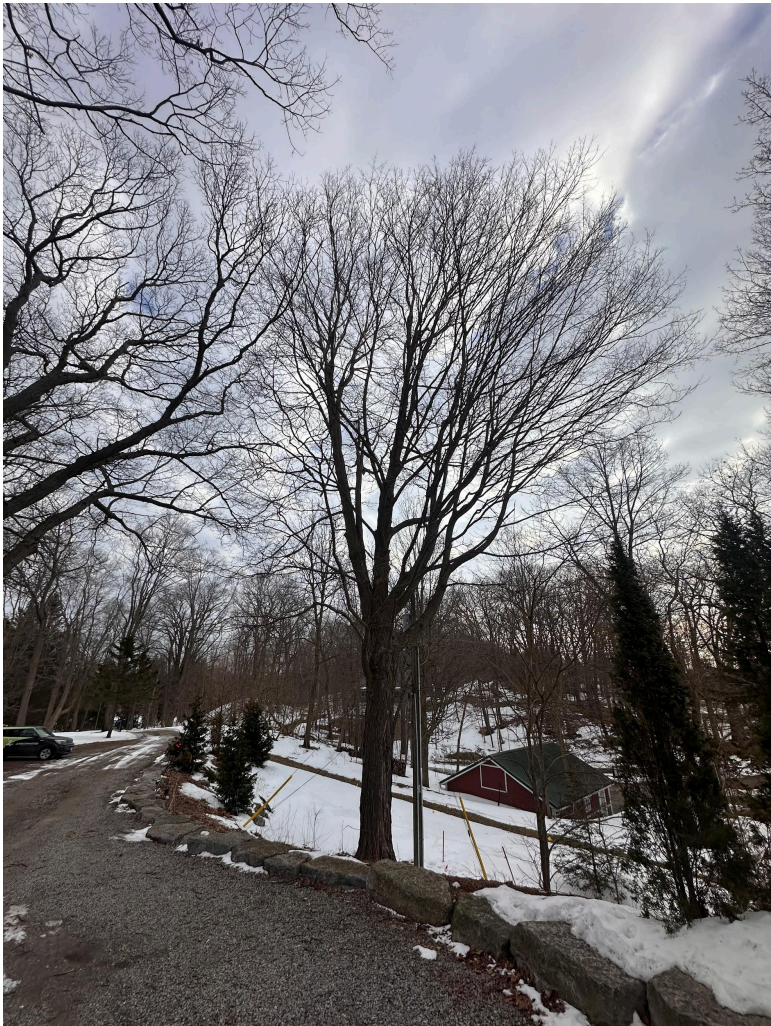
Tree 1

Tree No.	Tree Species	Tree DBH (cm)	Tree TPZ (m)	Tree Health (Good, Fair, Poor, Dead)	Tree Structure (Good, Fair, Poor, Dead)	Tree Ownership (Private, Public, Shared, Neighbour)	Action: Protect, Retain, Injure, Destroy (Remove)	Notes / Mitigative Measures
1	Sugar Maple	87	5.4	F	F	Private	REMOVE	Deadwood, hangers. 1.8m from center of tree to south corner of detached garage. Remove subject tree. 4:1 tree replacement ratio
2	Sugar Maple	79	4.8	F	F	Private	Retain	
3	Red Oak	84	5.4	G	F	Private	Retain	Pruned back from driveway
4	Red Oak	84	5.4	G	G	Private	Retain	
5	Red Oak	94	6.0	F	F	Private	Retain	Large co dominant stem over the driveway
6	Red Oak	89	5.4	F	F	Private	Retain	Crack on the backside of tree. Response growth present. Lean and phototropism
7	Norway Spruce	13	2.4	DEAD	F	Private	Retain	Dead
8	Norway Spruce	20	2.4	F-P	F	Private	Retain	Gall identified on branches
9	Dawn Redwood	15	2.4	G	F	Private	Retain	Typical growth pattern for species. Lower branching

- Removal of subject tree 1. Subject tree 1 is requested for removal as the proposed project is intended to injure a significant amount of the tree's structural root system.

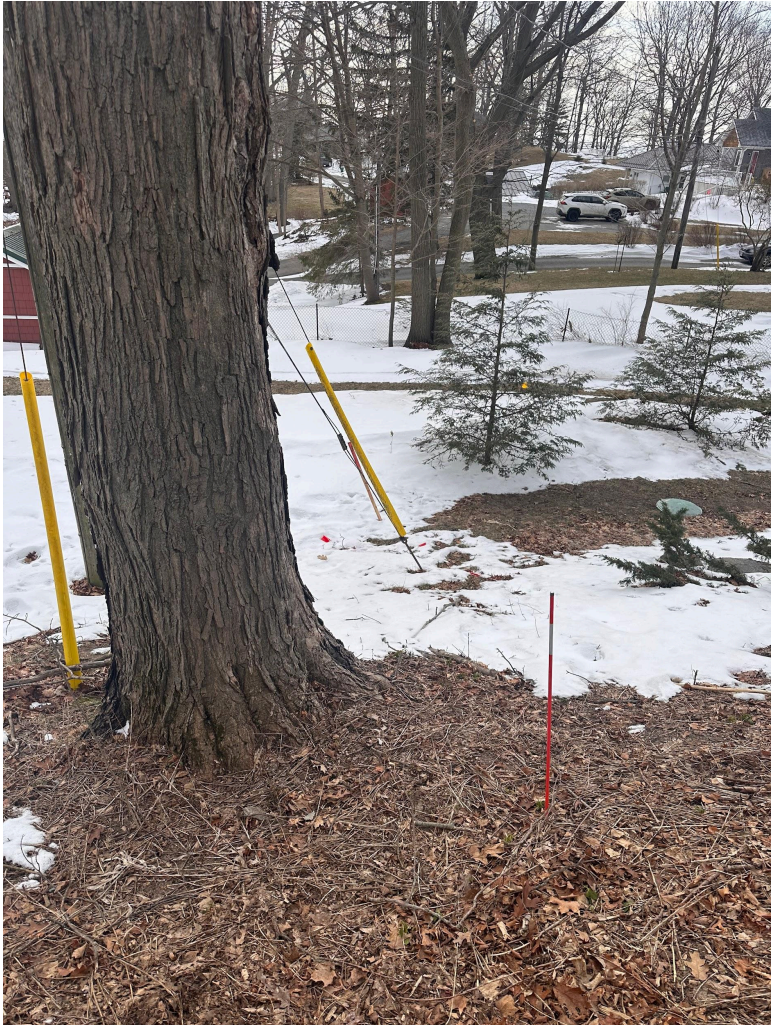
Tree 1 and location of the East corner of the proposed detached garage (orange stake)

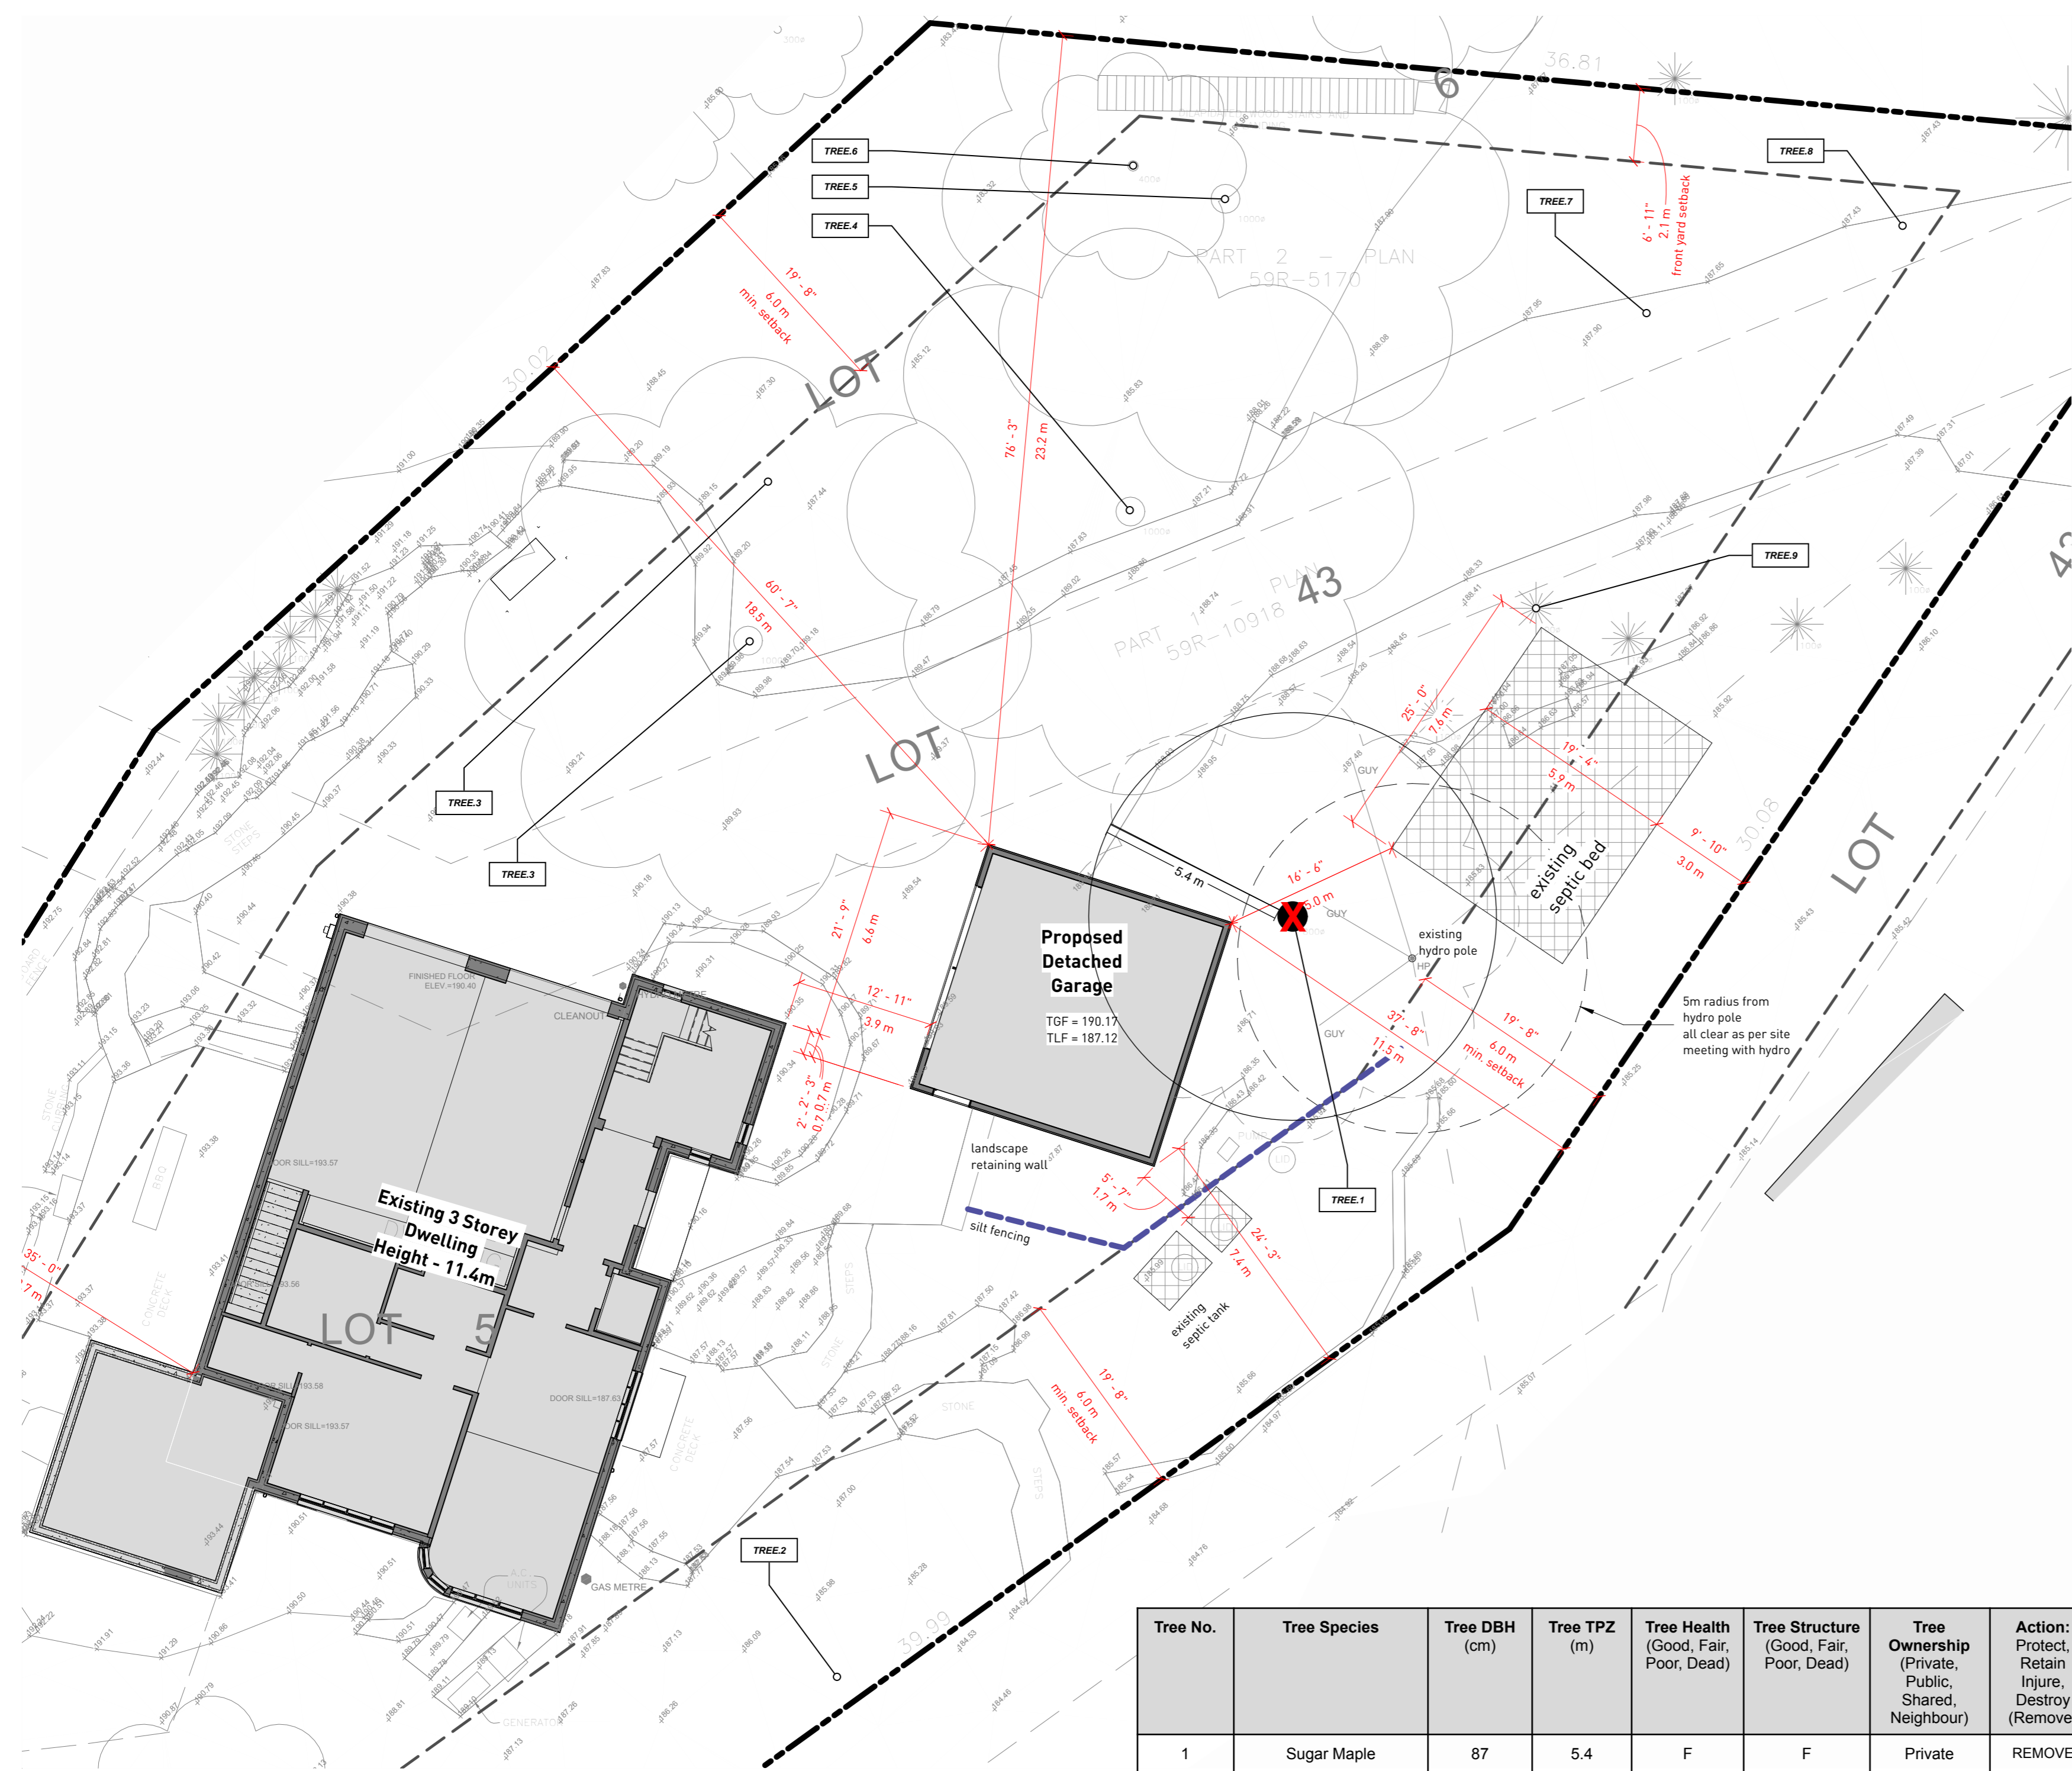
- Remove subject tree 1
- Replanting plan on site of 4 native species
- Removal of 3-5 Emerald Cedars (under 10cm DBH) in landscape wall next to proposed detached garage
- Silt fencing at South side of proposed project
- Construction Route Access on existing gravel driveway
