Coastal Study

2L49 Lakeshore Road
Wainfleet, Ontario

GHD was retained by Mr. Rob McDowell to complete a Coastal Study in support of a proposed single family residential development at 2L49 Lakeshore Road in Wainfleet, Ontario (hereinafter referred to as the site or subject property) on the shore of Lake Erie. GHD understands that it is the intention of the property owner to construct a building with full basement and sewage disposal system on the currently undeveloped property. This development was previously assessed by AMEC in 2010, and the now 10-year old documents have been reviewed by GHD to assess any required updating in order to align current regulations and guidelines. Based on the Record of Pre-Consultation document, it was concluded that the Slope Stability Assessment, including the Review of the 2010 Study, should be updated to include a Coastal Study, which would address the existing wave-based erosion and flood hazards, as well as list potential mitigation methods (if necessary). This Coastal Study addresses the required updates, coastal processes (from regional and local perspectives), natural hazard limits, and recommendations for mitigation methods and next steps

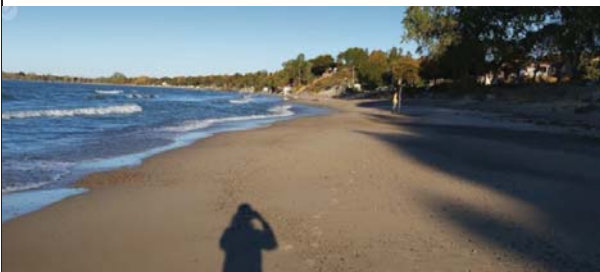
25 m -30 m wide beach on subject property, facing west

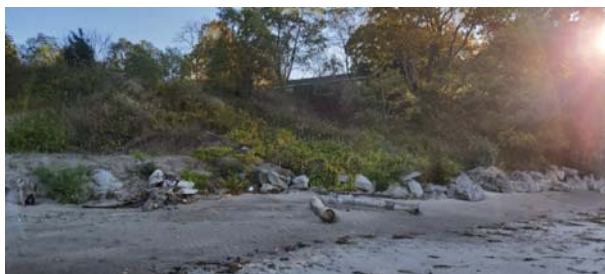
Toe of western side of dune

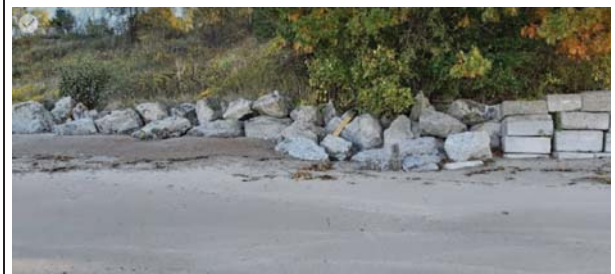
Toe of eastern side of dune

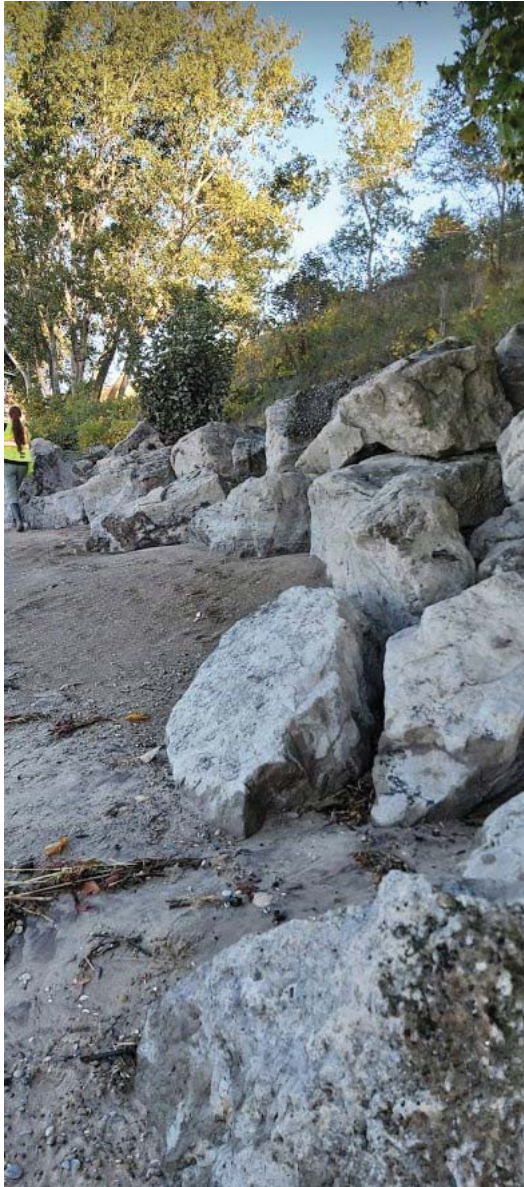
Toe of dune showing large armourstone,
facing west

The aerial photograph review also indicated no evidence of the rock revetment constructed at the toe of the dune until 2000. Further, there is no evidence of erosion of the dune between the years of 2000 and 2018.

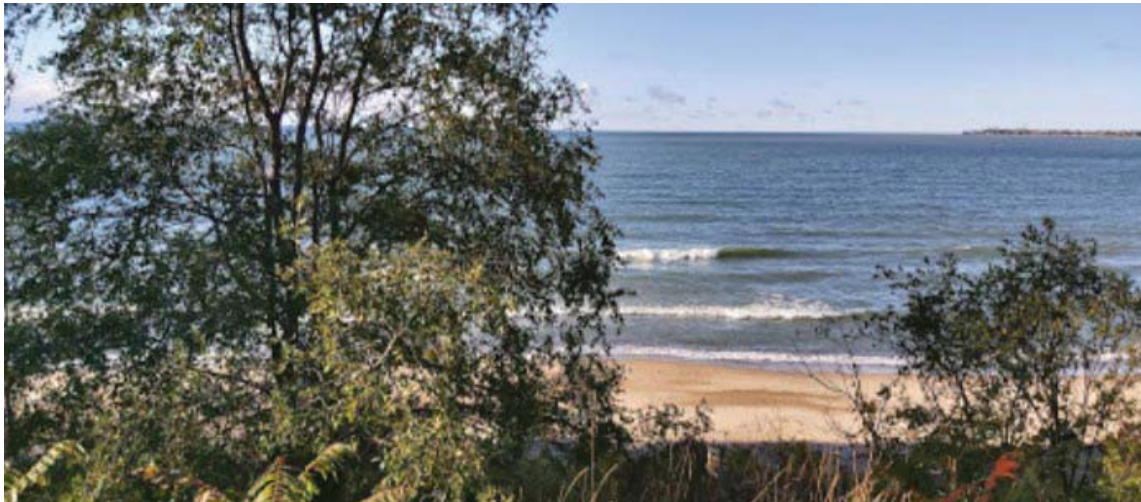
View from the top of the dune. Overlooking heavy vegetation leading down to the wide beach.

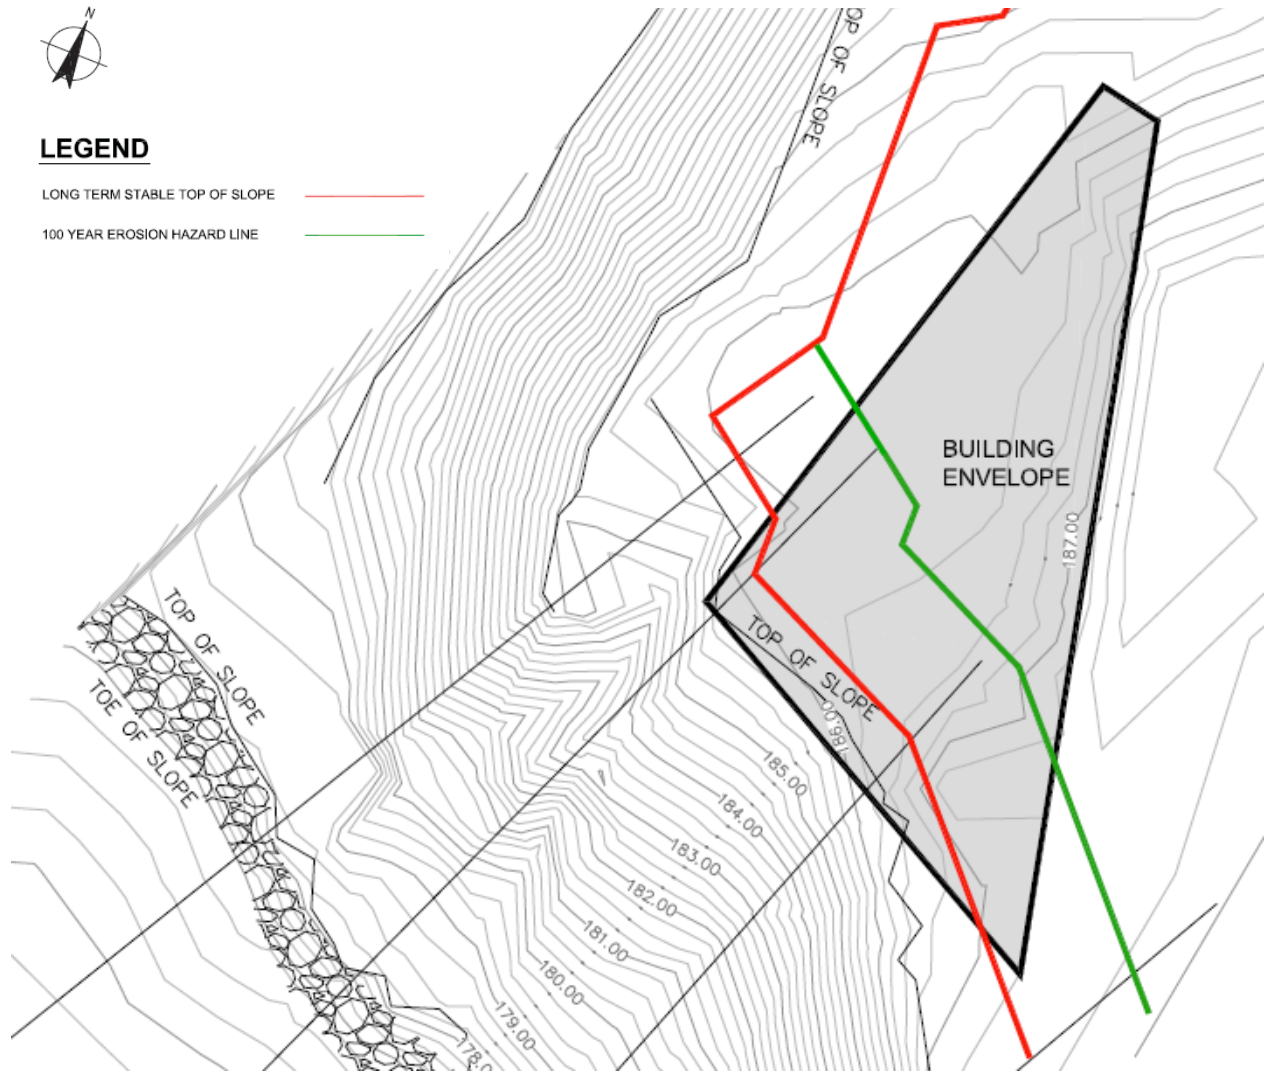
Figure 4 Long-Term Stable Top of Slope and 100-Year Erosion Hazard Line

Based on the foregoing, there would be 5.61 m of erosion over the next 100 years assuming that the rock revetment is not reconstructed after 49 years and 0.11 m of erosion occurs in each of the remaining 51 years. As such, the site-specific erosion hazard limit should be considered at 5.61 m set back from the Stable Top of Slope (on the lake-facing slope only) as provided in the Geotechnical Slope Stability Review (GHD, 2020) and shown as the 100-Year Erosion Hazard Line on Figure 4.

Based on the Coastal Study, including review of historical information, a site inspection, review of NPCA regulatory requirements, and development of site-specific erosion rates, the current lake-facing slope could erode 5.6 m in the next 100 years. A newly constructed revetment would reduce this erosion to 3.3 m over the next 100 years. It is noted that the proposed building footprint would still be within the erosion hazard if a new revetment is installed. Annual visual assessments of the vegetation on the dune are recommended in order to determine whether the existing rock revetment is fulfilling its design purpose against significant erosion, as would be indicated by the progressive disappearance of vegetative cover on the dune.

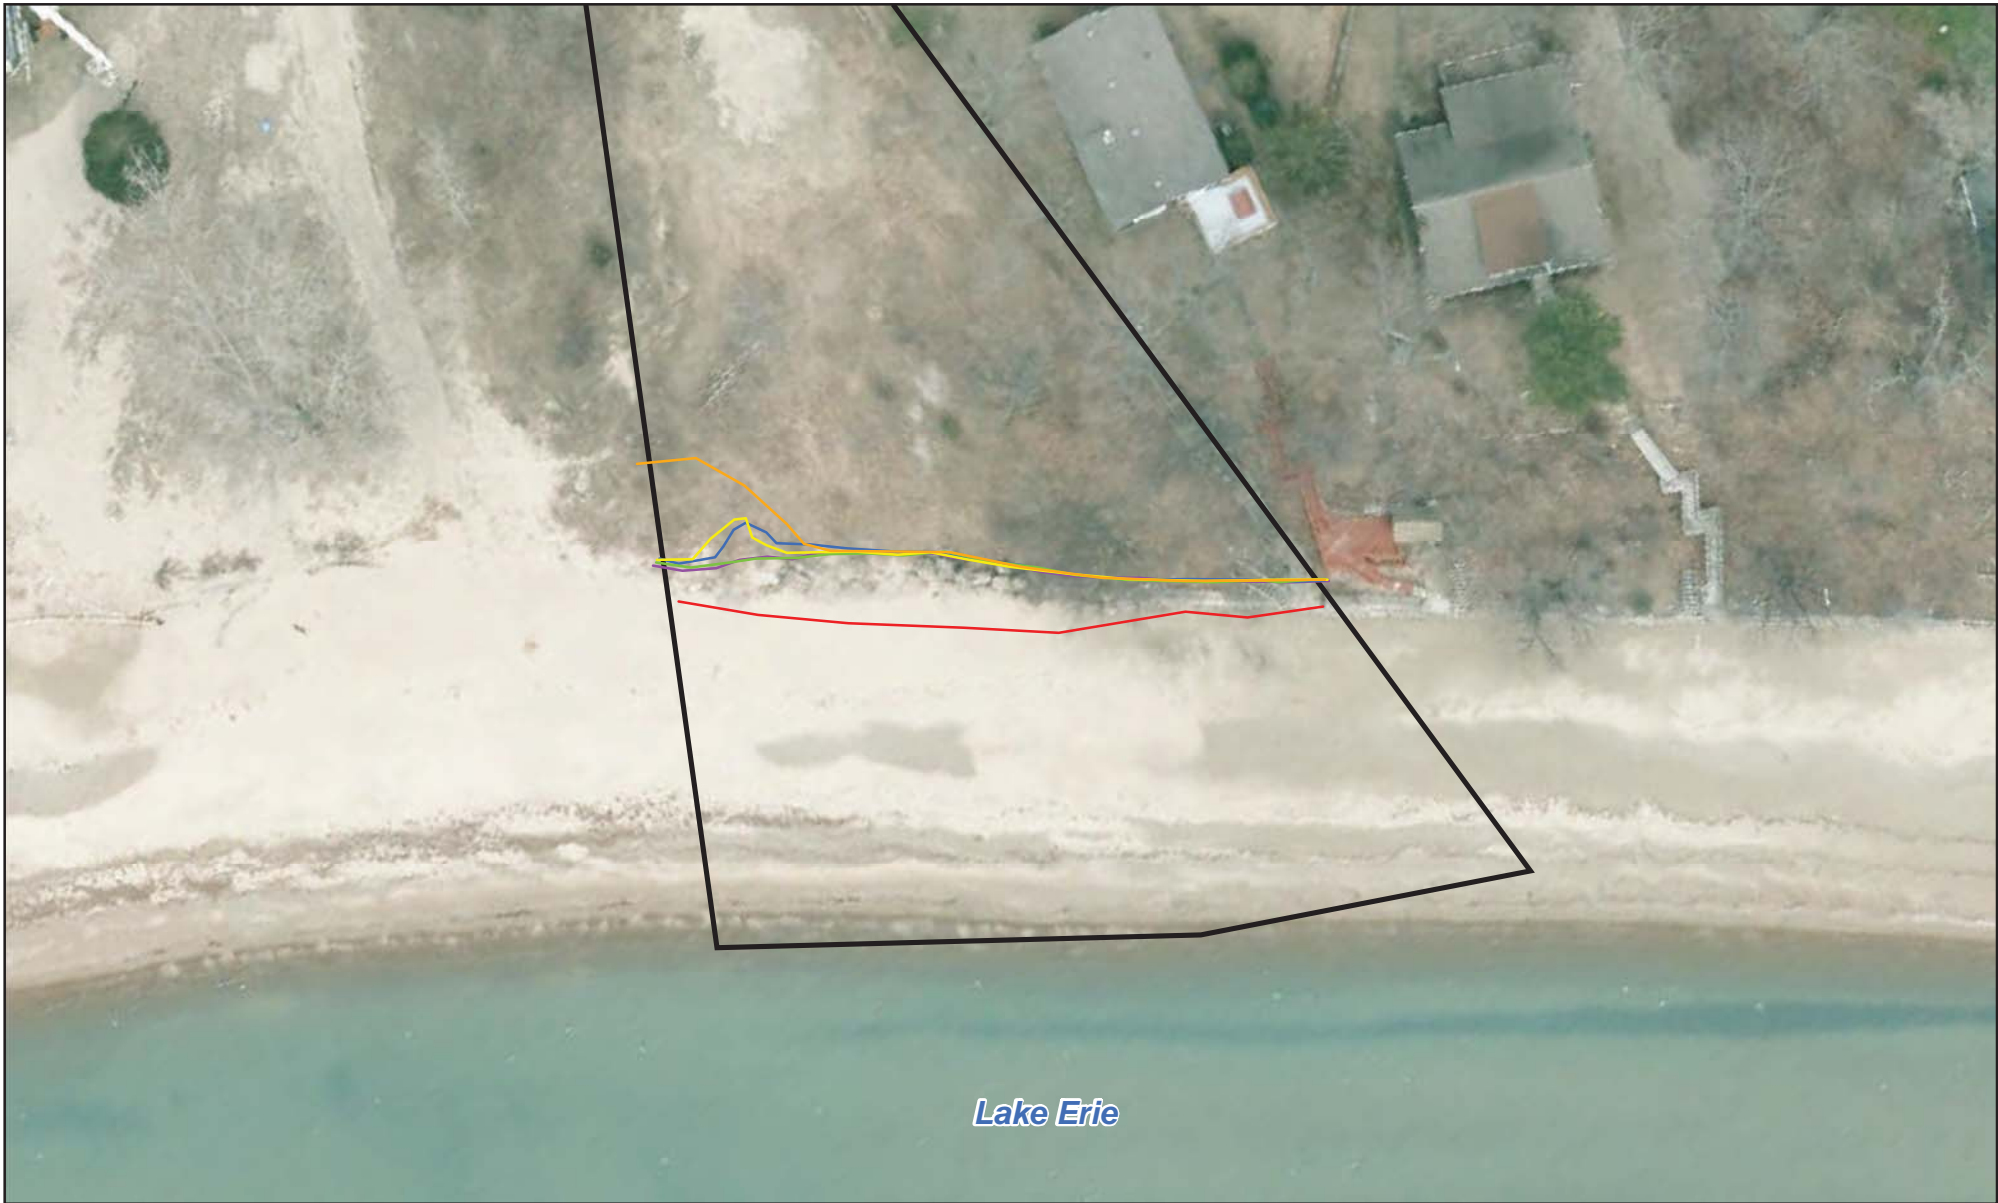
FIGURE 1

- Approximate Foot of Dune**
- 1954
 - 2000
 - 2010
 - 2013
 - 2018

HISTORIC EROSION ANALYSIS

Publicly available photographs of sufficient quality were obtained and reviewed by GHD for the years 1954, 2000, 2006, 2010, 2013, and 2018. Comparison of these photographs revealed that there is a maximum change in the dune vegetation line (toe of the dune) of 5.2 m inland between 1954 (red line) and 2000-2018 (orange, yellow, green, blue, purple lines), as shown on Figure 3.
