Reference No. 11218340

**Re: Geotechnical and Slope Stability Review  
Proposed Residential Development - 2L49 Lakeshore Road, Wainfleet, Ontario**

**MCDOWELL RESIDENCE**  
**2L49 (10288) LAKESHORE ROAD, WAINFLEET, ON**  
**SLOPE STABILITY EVALUATION**

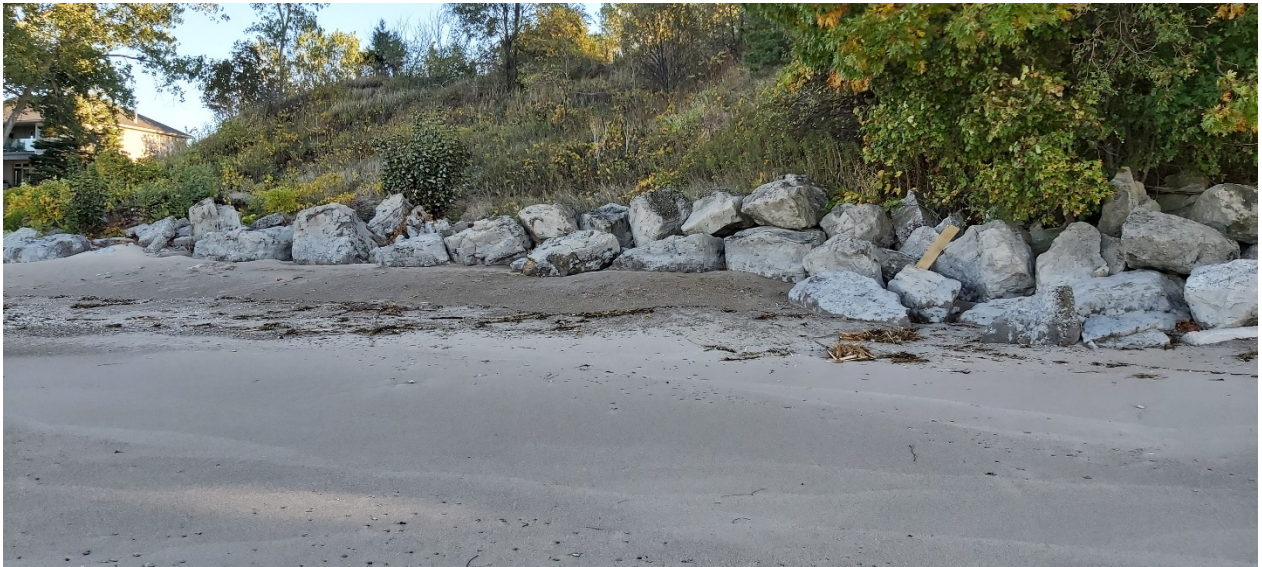
**Figure 1.1 Relatively steep shoreline slope**

binder, acting to hold the deposit together. Upon wetting, however, either the water soluble calcium carbonate bonds dissolve or the large negative pore pressures within the clay that are holding the deposit together are reduced, resulting in increased likelihood of shear failure and/or large settlement. This cementation can impart pseudo cohesive properties<sup>3</sup> when samples of eolian deposits are tested for shear strength and can also enable these weakly to moderately cemented deposits to stand at relatively steep slope angles, as is seen at the Site in the photograph below.

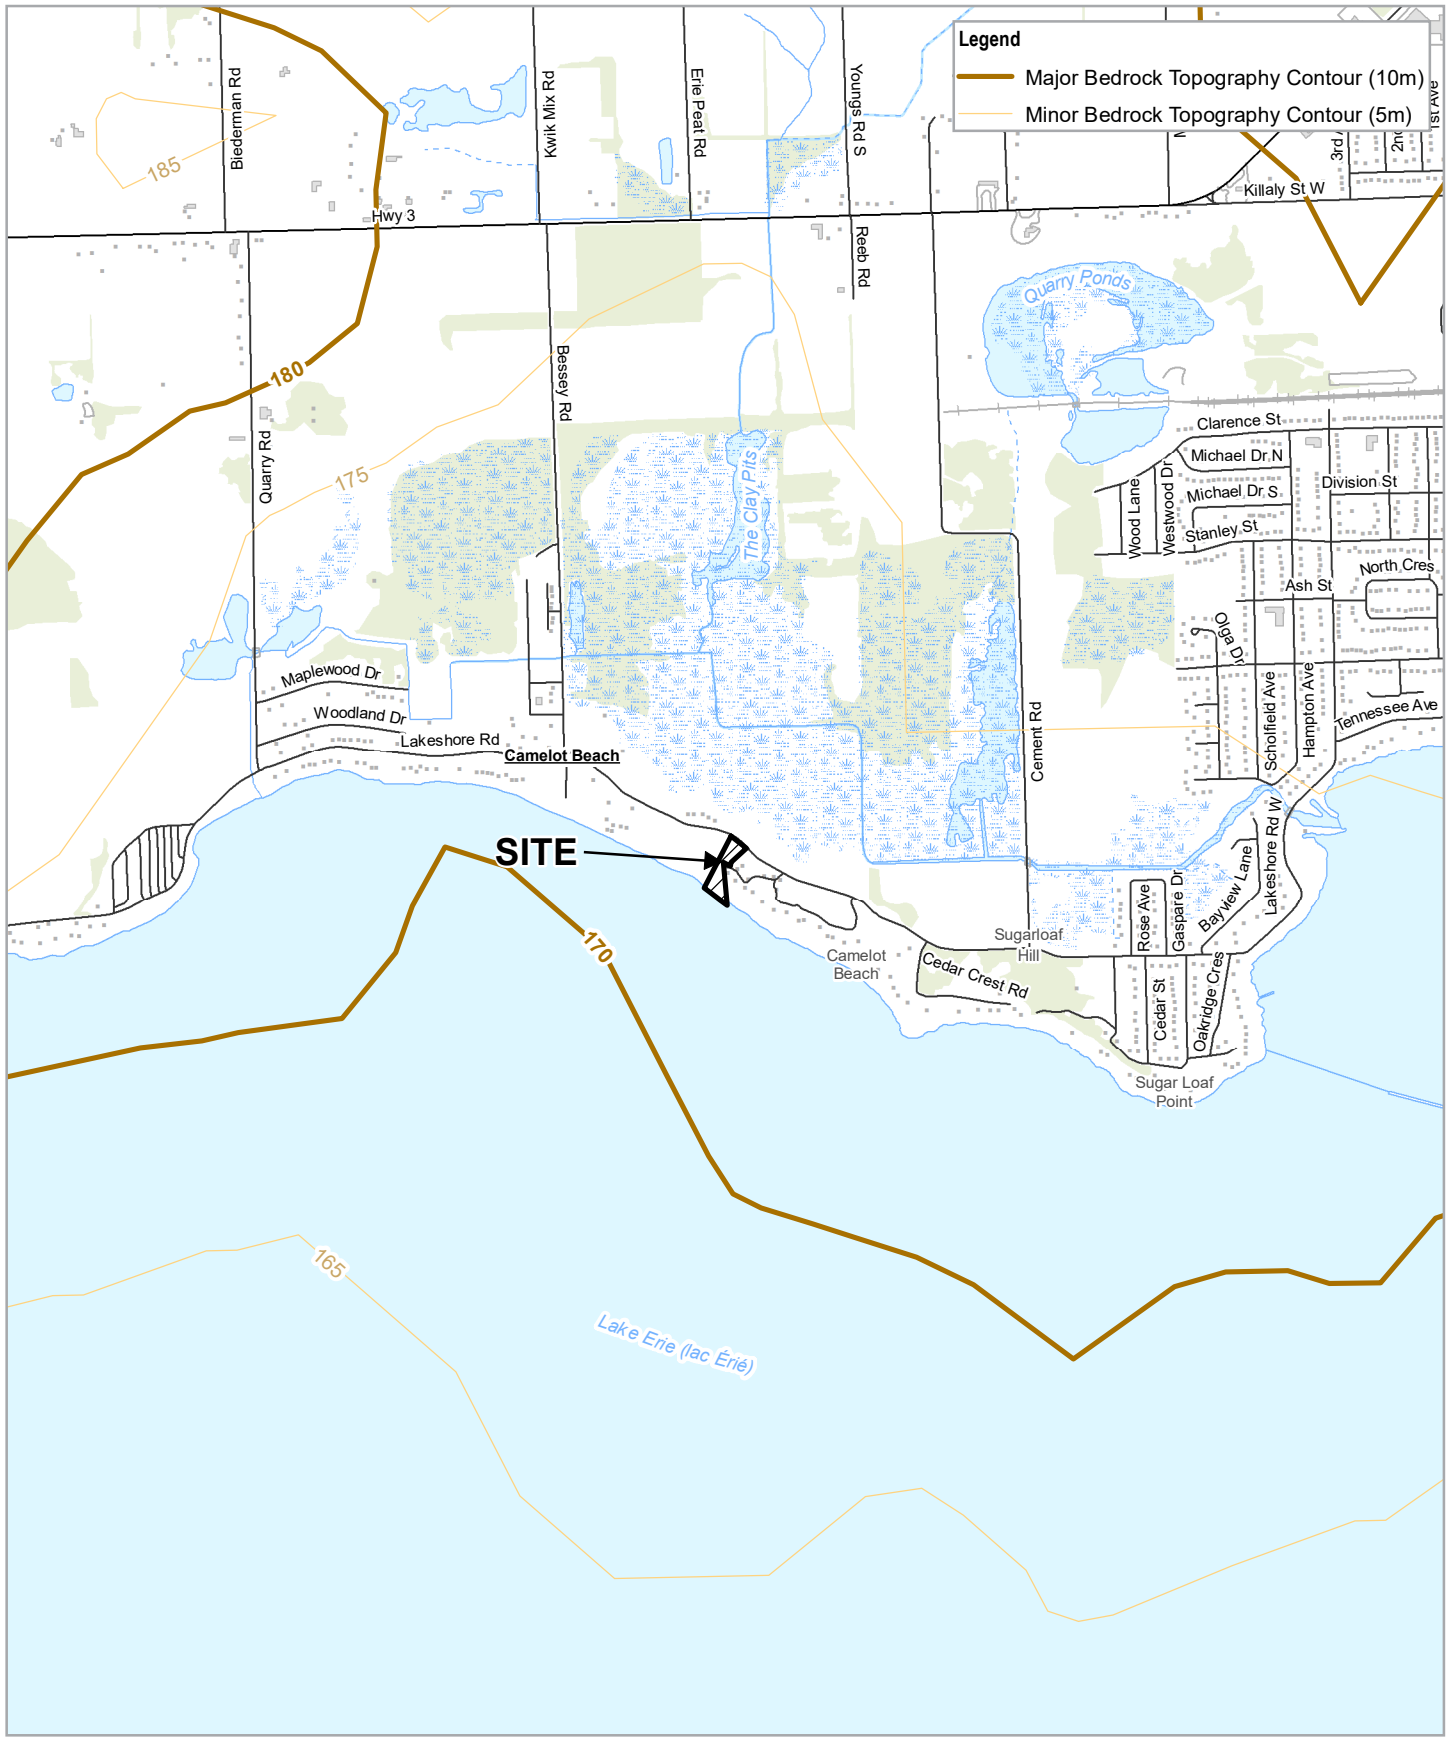
**FIGURE 4**

**BEDROCK TOPOGRAPHY**

The bedrock underlying the soil overburden in the region and at the Site, consists of sedimentary rock (limestone, dolostone, shale) of the Detroit River Group, Onondaga Formation<sup>4</sup>, as shown on Figure 3. This bedrock is expected to be encountered between 175 m amsl and 170 m amsl based on the bedrock topography maps<sup>5</sup> as shown on Figure 4.

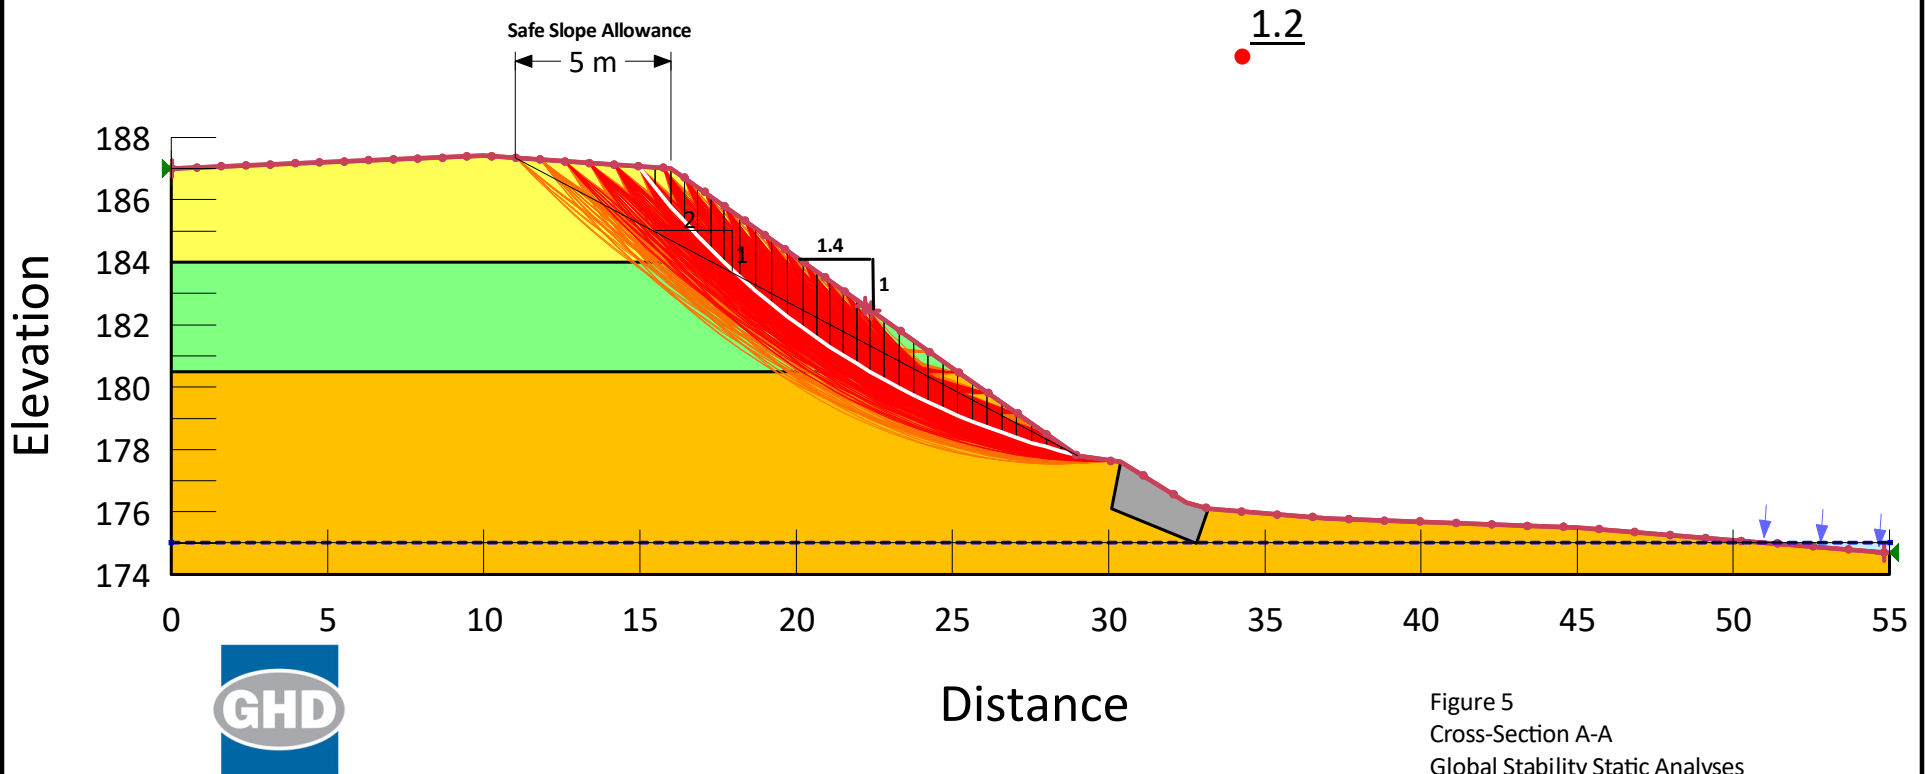
| Color | Name | Unit Weight (kN/m <sup>3</sup> ) | Cohesion' (kPa) | Phi' (°) |
| Yellow | Compact Eolian Sand | 19 | 6 | 37 |
| Orange | Compact Foreshore Sand | 18 | 0 | 37 |
| Light Green | Loose Eolian Sand | 19 | 3 | 30 |
| Grey | Stone Revetment | 26 | | |

Figure 5  
 Cross-Section A-A  
 Global Stability Static Analyses  
 Proposed Residential Redevelopment  
 2L49 Lakeshore Road, Wainfleet, Ontario

Analyses were performed on two cross sections identified as A-A and D-D on the topographic survey included as Attachment A. The stability analyses are included as Figure 5 to Figure 8 in Attachment B. Both static and pseudo-static (i.e., seismic) conditions were analyzed for the selected cross-sections. Cross-section A-A has the steepest gradient of 1.4H:1V and cross-section D-D has a slope gradient of 2H:1V.

The slope stability analysis was carried out using the SLOPE/W 2019 R2 software package produced by GEO-STUDIO International Ltd. Each trial was modeled using the Morgenstern-Price method, and the optimized critical slip-surface was selected. In general, this approach calculates a factor of safety that represents the ratio of forces resisting a failure (i.e., shear strength, friction, etc.) to those favouring failure (weight, external loading, etc.). Theoretically, a factor of safety of 1.0 or greater would represent a stable slope. The Ontario Ministry of Natural Resources and Forestry (MNRF)<sup>6</sup> has developed a table of recommended minimum factors of safety based on the land use above or below the slope. These factors of safety take into account the consequences or risks to land use or life of a slope failure. The MNRF recommended factors of safety are reproduced below,

| Analysis | Cross-Section/<br>Figure | Gradient<br>(H:V) | Factor of Safety | | Stable Slope<br>setback<br>Allowance (m) <sup>(1)</sup> |
|---|---|---|---|---|---|
| Global Stability - Static | A-A Figure 5 | 1.4:1 | 1.5 | 1.2 | 5.0 |

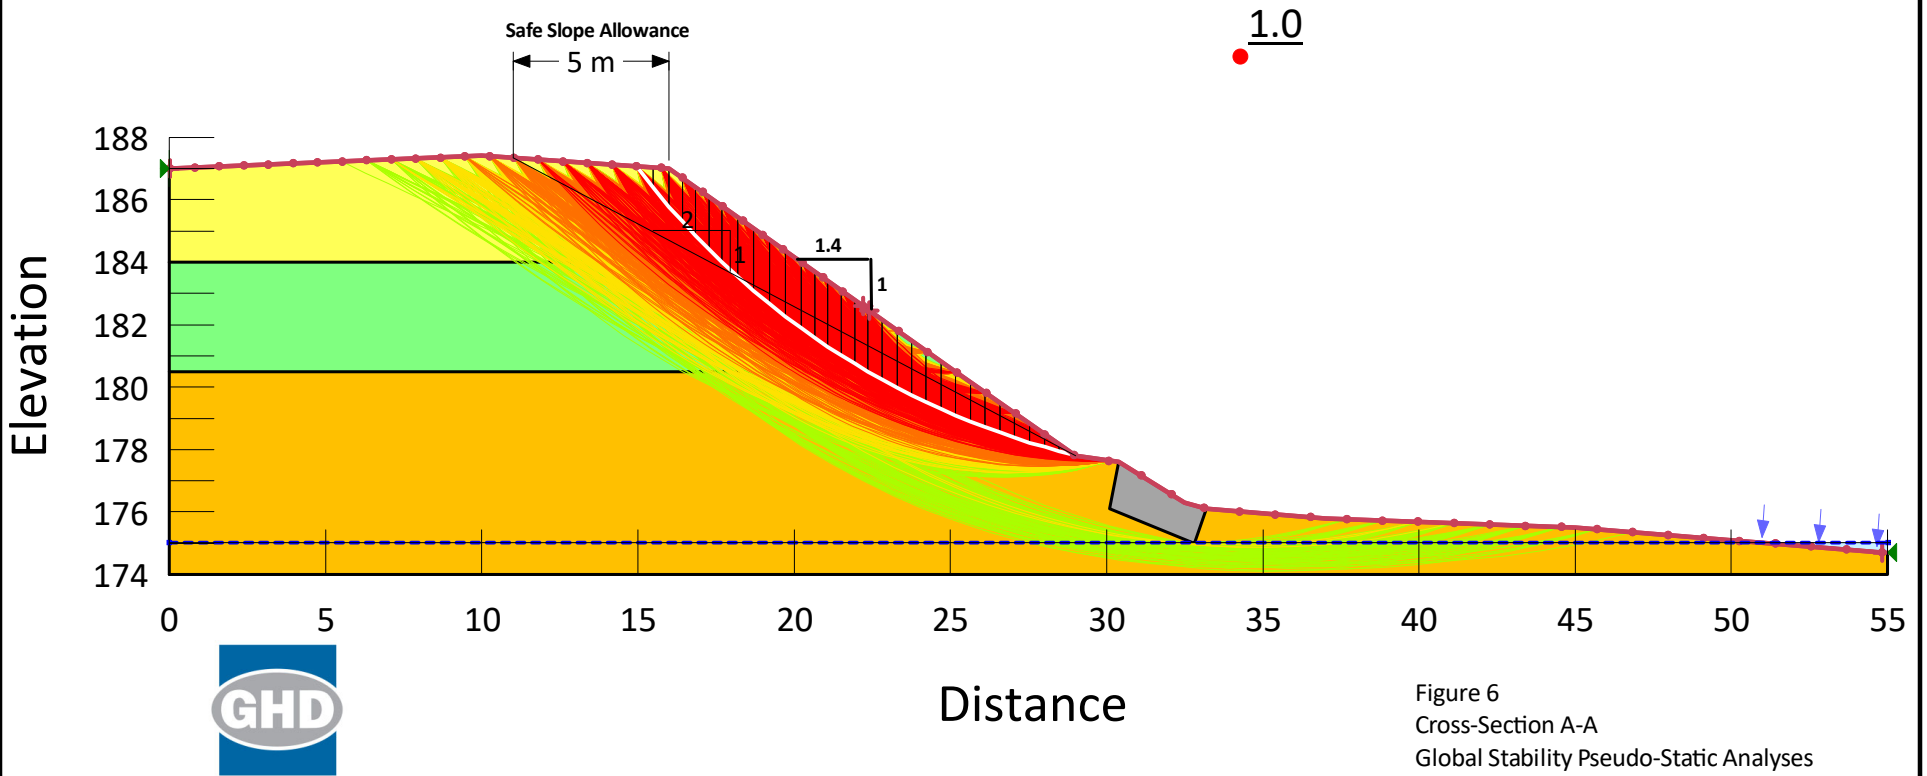
| Color | Name | Unit Weight (kN/m <sup>3</sup> ) | Cohesion' (kPa) | Phi' (°) |
| Yellow | Compact Eolian Sand | 19 | 6 | 37 |
| Orange | Compact Foreshore Sand | 18 | 0 | 37 |
| Light Green | Loose Eolian Sand | 19 | 3 | 30 |
| Grey | Stone Revetment | 26 | | |

Figure 6  
 Cross-Section A-A  
 Global Stability Pseudo-Static Analyses  
 Proposed Residential Redevelopment  
 2L49 Lakeshore Road, Wainfleet, Ontario

- A global stability of the overall slope under pseudo-static condition – in this analysis a horizontal coefficient of 50% of the PGA (under 2% probability of exceedance in 50 years) which is equal to 0.092 at the site location was assumed for seismic loading.

| Analysis | Cross-Section/<br>Figure | Gradient<br>(H:V) | Factor of Safety | | Stable Slope<br>setback<br>Allowance (m) <sup>(1)</sup> |
|---|---|---|---|---|---|
| Global stability - Pseudo Static | A-A Figure 6 | 1.4:1 | 1.0 | 1.0 | 2.0 |

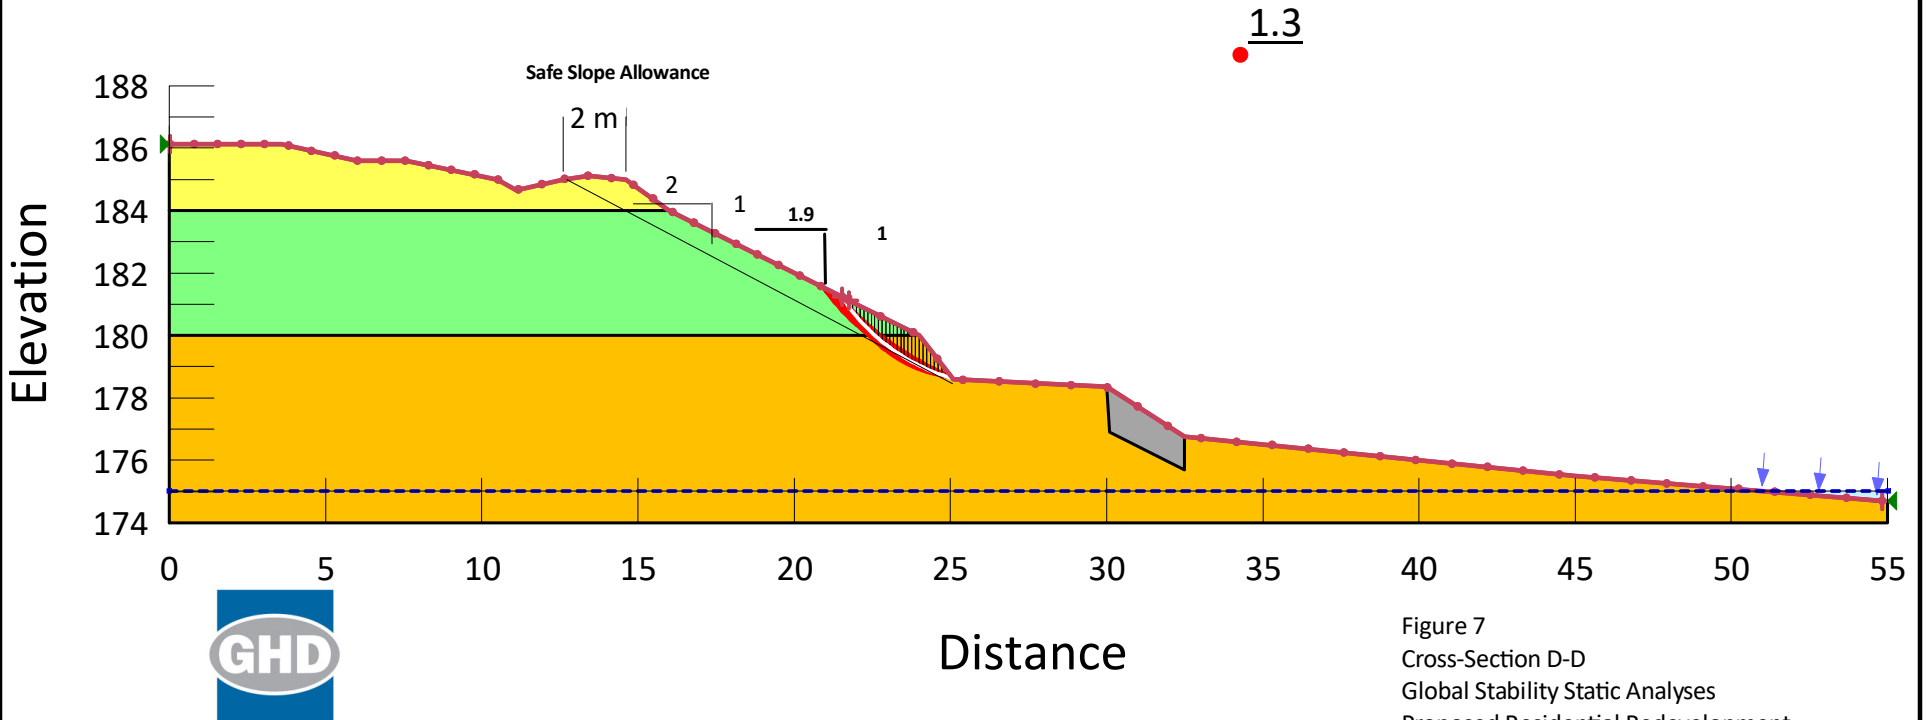
| Color | Name | Model | Unit Weight (kN/m <sup>3</sup> ) | Cohesion' (kPa) | Phi' (°) |
| Yellow | Compact Eolian Sand | Mohr-Coulomb | 19 | 6 | 37 |
| Orange | Compact Foreshore Sand | Mohr-Coulomb | 18 | 0 | 37 |
| Light Green | Loose Eolian Sand | Mohr-Coulomb | 19 | 3 | 30 |
| Grey | Stone Revetment | High Strength | 26 | | |

Figure 7  
 Cross-Section D-D  
 Global Stability Static Analyses  
 Proposed Residential Redevelopment  
 2L49 Lakeshore Road, Wainfleet, Ontario  
 11218340

| Analysis | Cross-Section/<br>Figure | Gradient<br>(H:V) | Factor of Safety | | Stable Slope<br>setback<br>Allowance (m) <sup>(1)</sup> |
|---|---|---|---|---|---|
| Global Stability - Static | D-D Figure 7 | 2.0:1 | 1.5 | 1.3 | 2.0 |

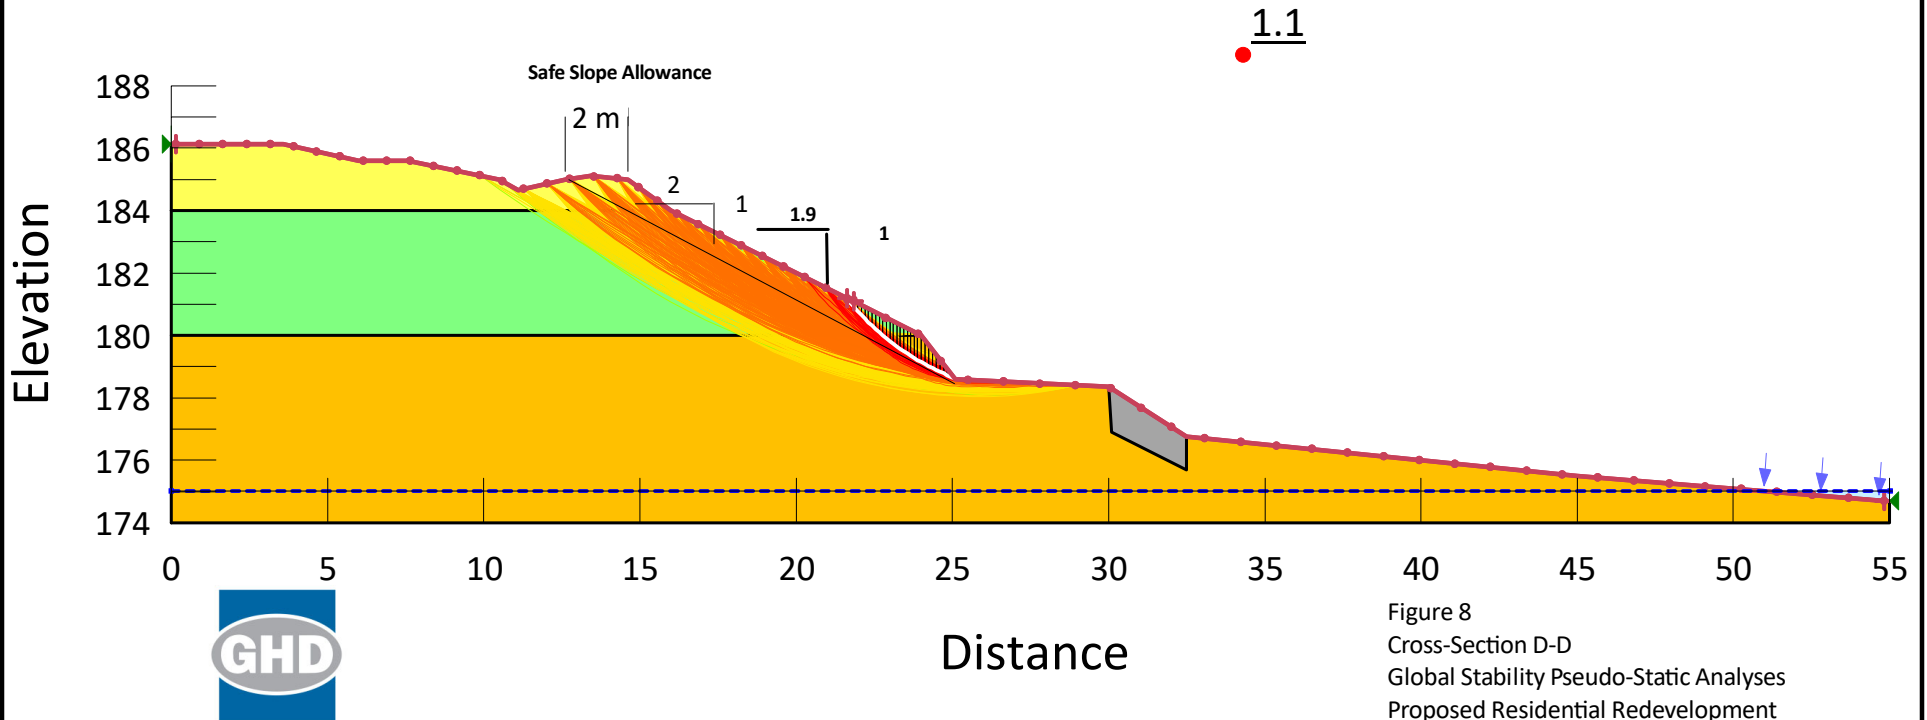
| Color | Name | Model | Unit Weight (kN/m <sup>3</sup> ) | Cohesion' (kPa) | Phi' (°) |
| Yellow | Compact Eolian Sand | Mohr-Coulomb | 19 | 6 | 37 |
| Orange | Compact Foreshore Sand | Mohr-Coulomb | 18 | 0 | 37 |
| Light Green | Loose Eolian Sand | Mohr-Coulomb | 19 | 3 | 30 |
| Grey | Stone Revetment | High Strength | 26 | | |

Figure 8  
 Cross-Section D-D  
 Global Stability Pseudo-Static Analyses  
 Proposed Residential Redevelopment  
 2L49 Lakeshore Road, Wainfleet, Ontario  
 11218340

| Analysis | Cross-Section/<br>Figure | Gradient<br>(H:V) | Factor of Safety | | Stable Slope<br>setback<br>Allowance (m) <sup>(1)</sup> |
|---|---|---|---|---|---|
| Global stability - Pseudo Static | D-D Figure 8 | 2.0:1 | 1.0 | 1.1 | 1.83 |

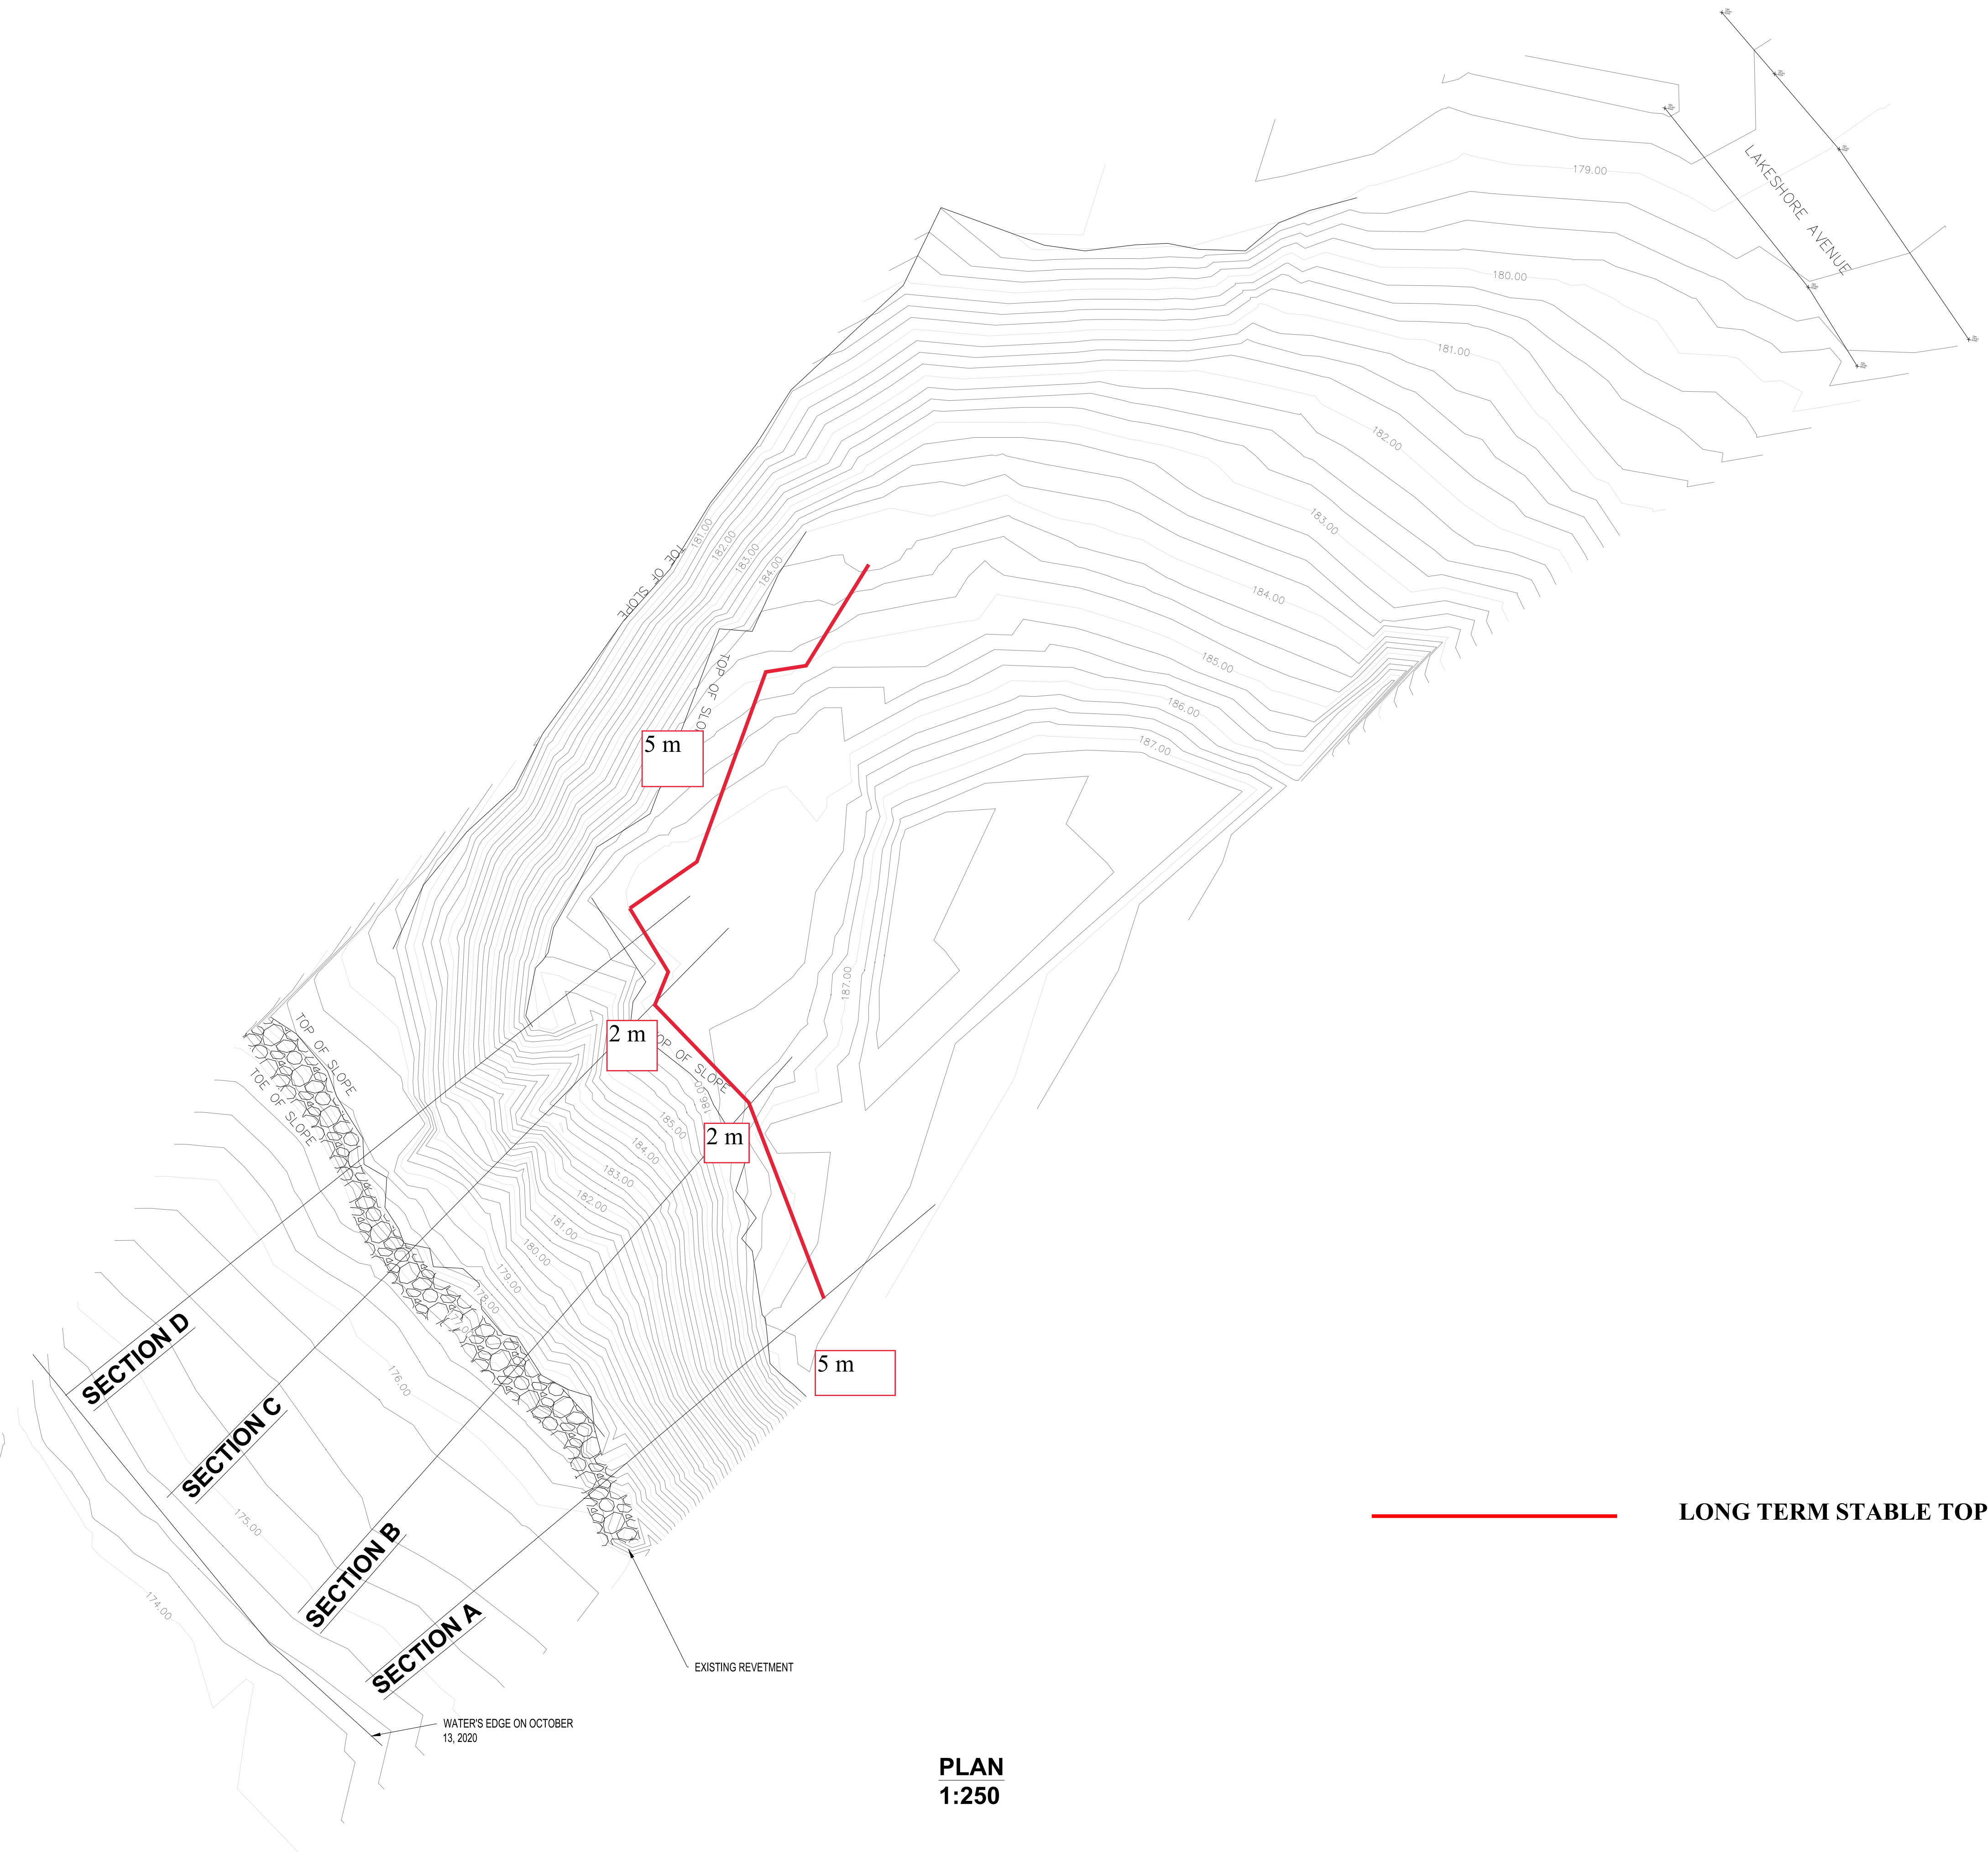
This Drawing must not be used for Construction unless signed as Approved  
 Drawing No. **11218340-Figure 9** Original Size **Arch D**  
 Rev. **001**

————— LONG TERM STABLE TOP OF SLOPE

Title **EXISTING  
CONDITIONS**

- Analyses completed show factors of safety less than 1.5 under static conditions. A factor of safety of 1.5 under static conditions was achieved at 5 m and 2 m, as measured from the top of the slope for the 1.4H:1V and 2H:1V slopes, respectively. A slope stability analysis was not completed for the west slope. Due to the similar steepness of the slope to Section A-A, it is recommended that a Stable Top of Slope setback allowance of 5 m should be used along the west side slope.
- Using the results of analyses discussed in the bullet item above, the recommended long term Stable Top of Slope allowance is shown on Figure 9.

growth will reduce the slope stability. As an alternative, the long-term stable top of slope can be considered at an offset distance of 2 m and 5 m inland from the existing top of slope at cross-sections A-A and D-D, respectively, which meets the AMEC 2H:1V slope criterion.

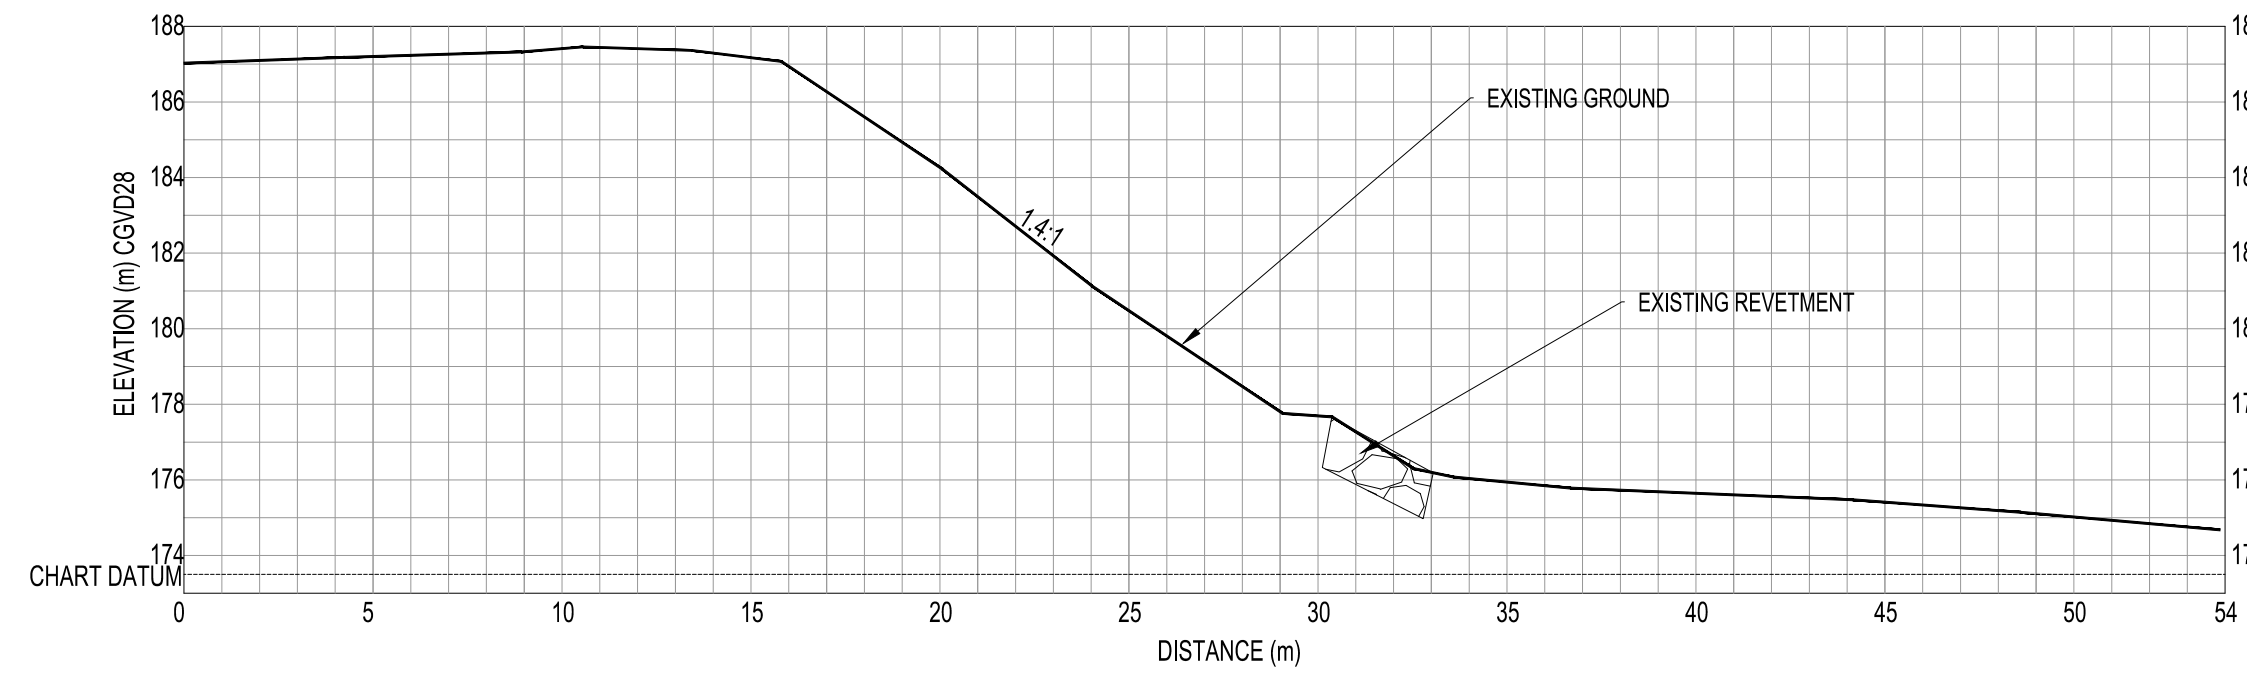
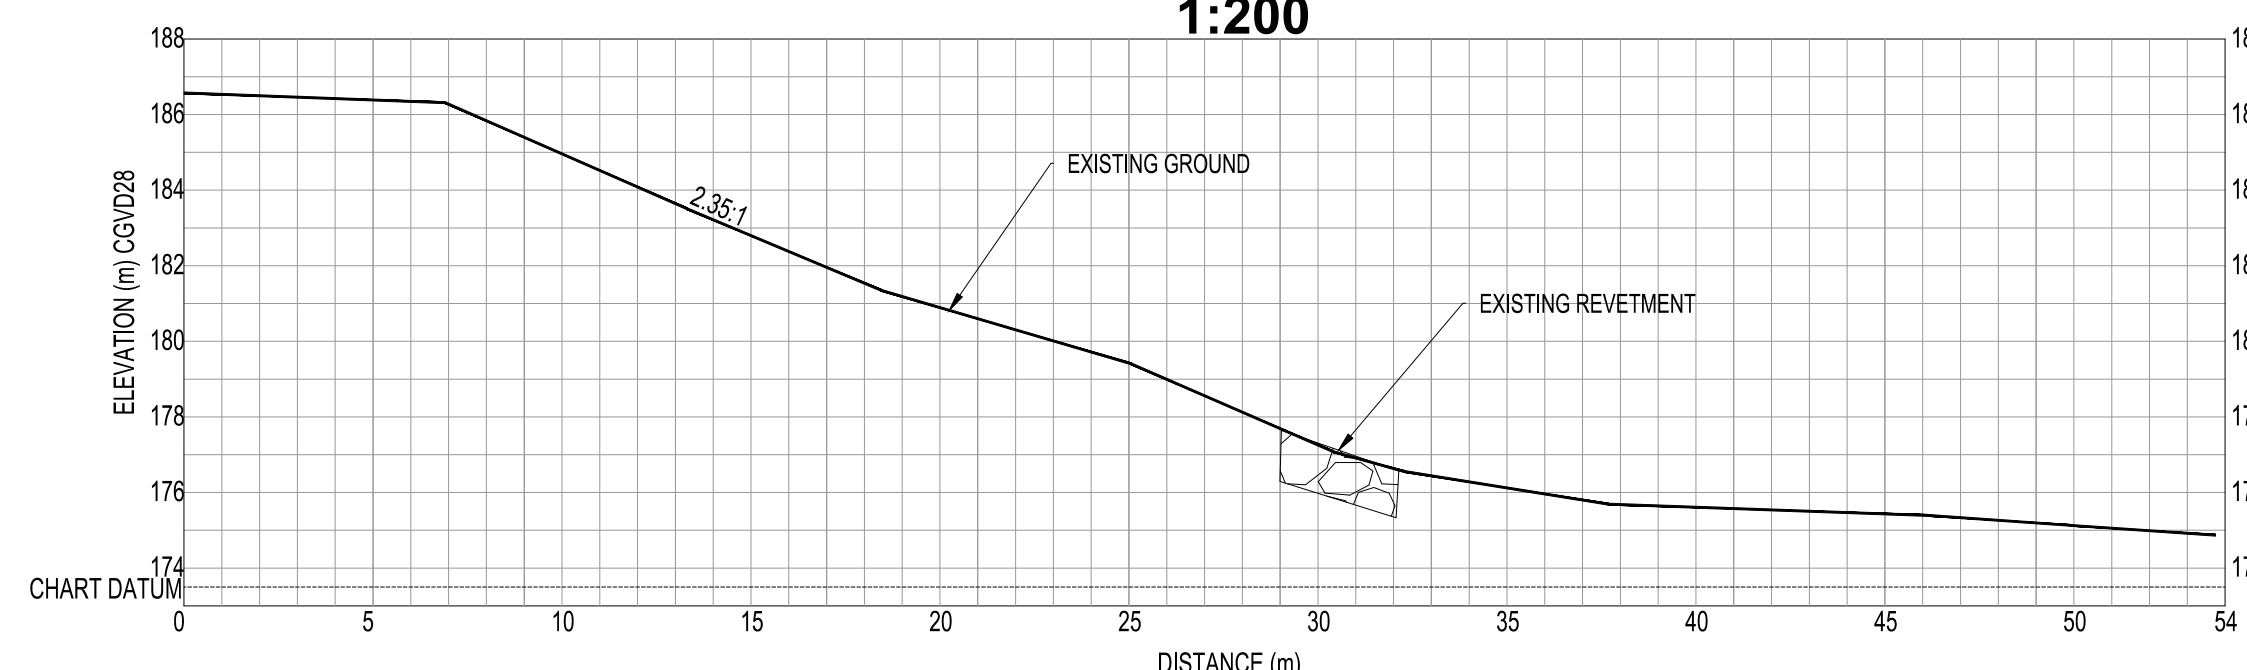
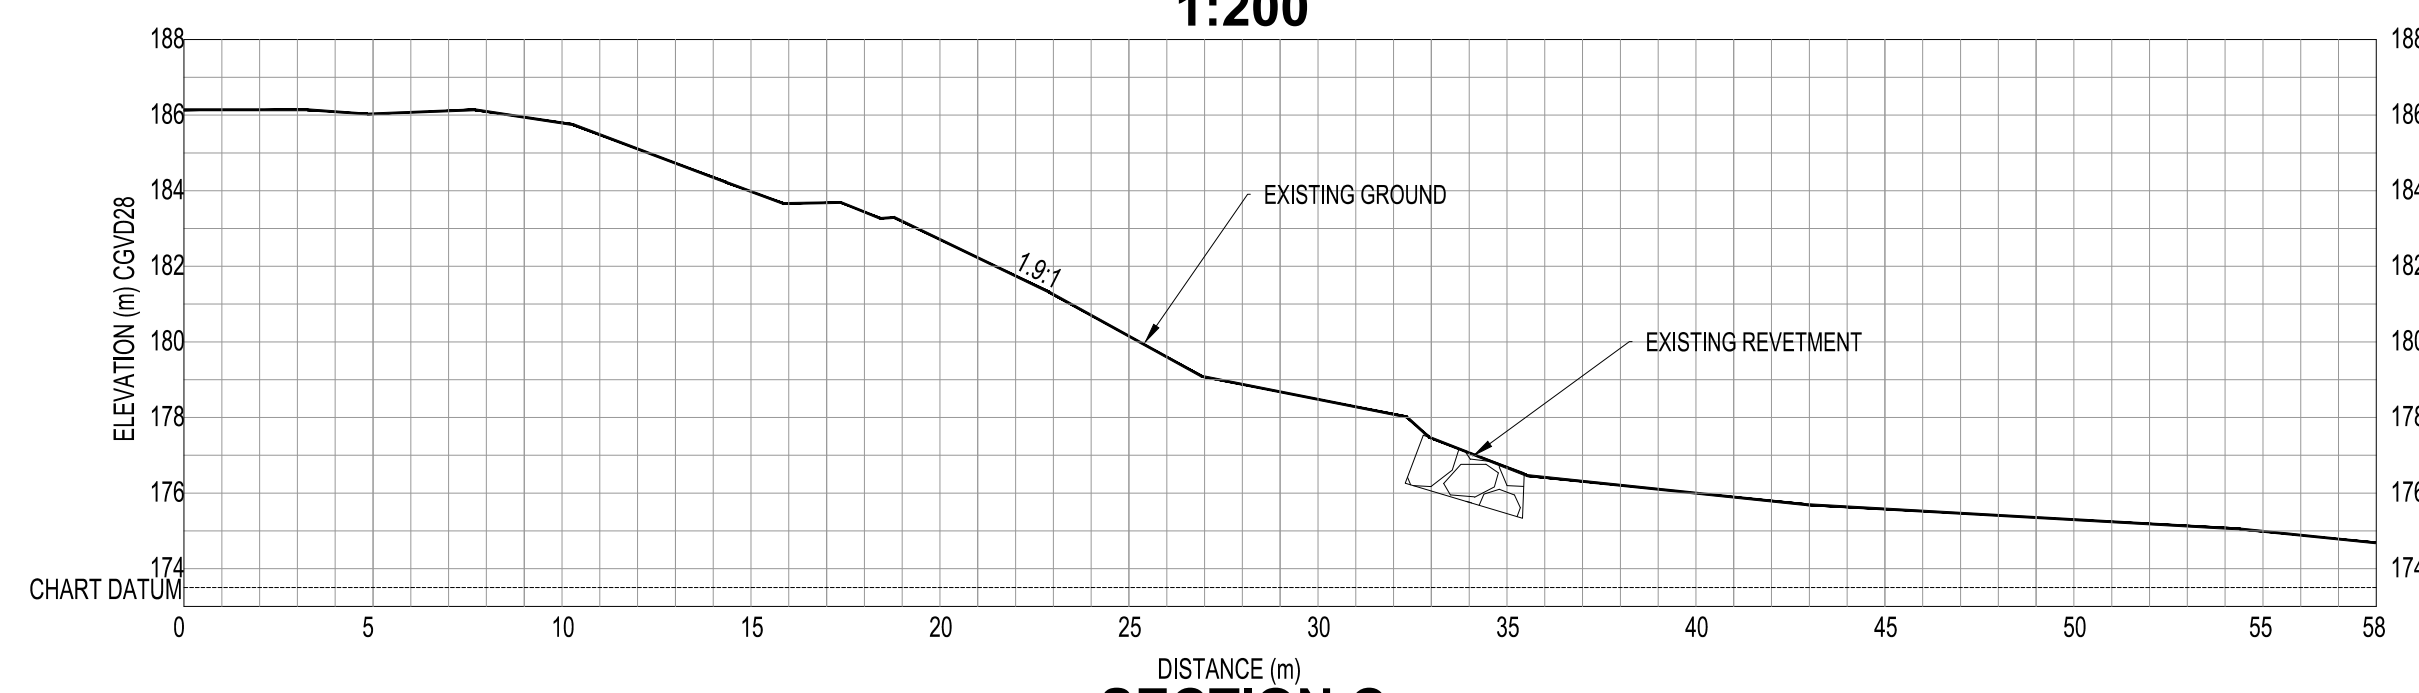
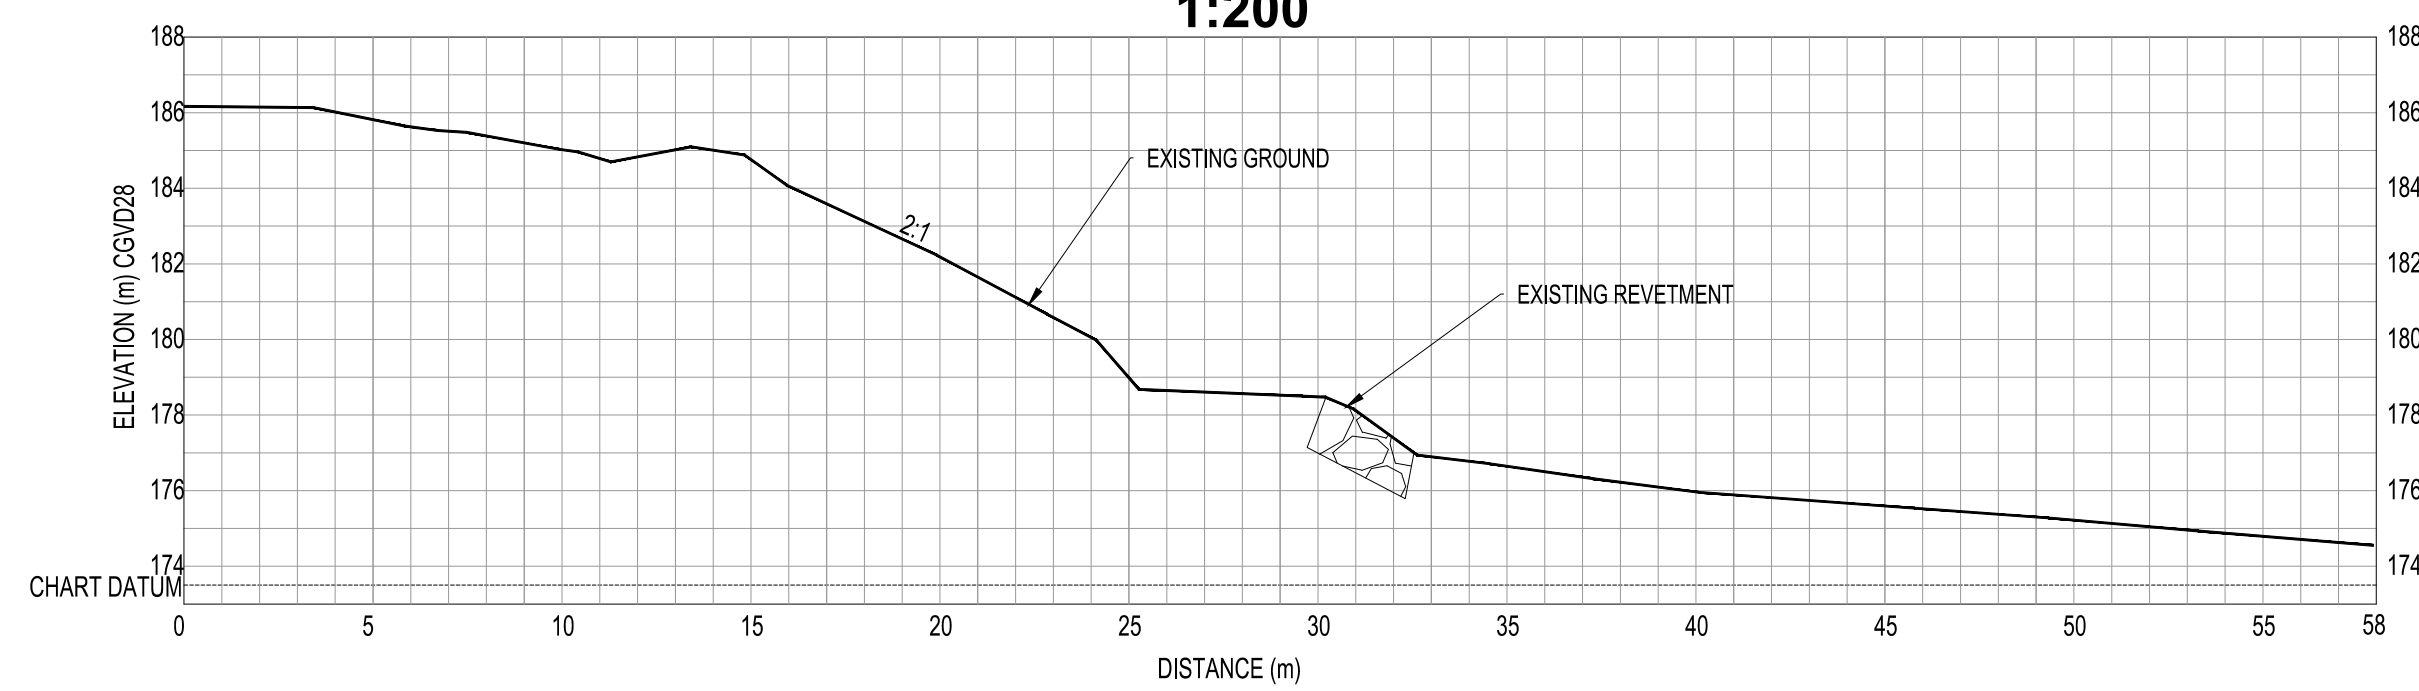
Drawing No. **11218340-Figure 10**

Title **EXISTING CONDITIONS CROSS SECTION**
