Wainfleet Library and Fire Station No. 2

Condition Assessment – 2015

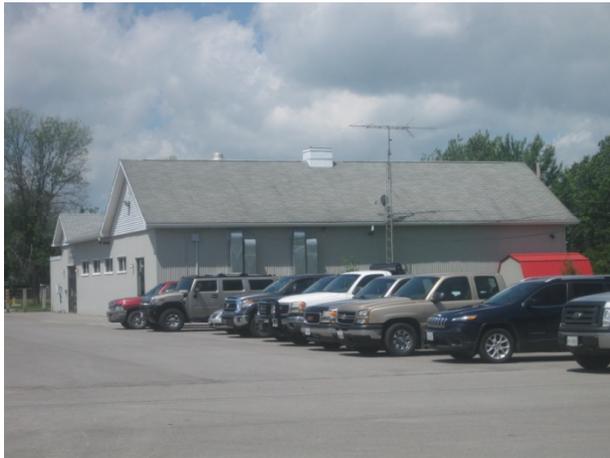
Photo 1 - East elevation (fire station)

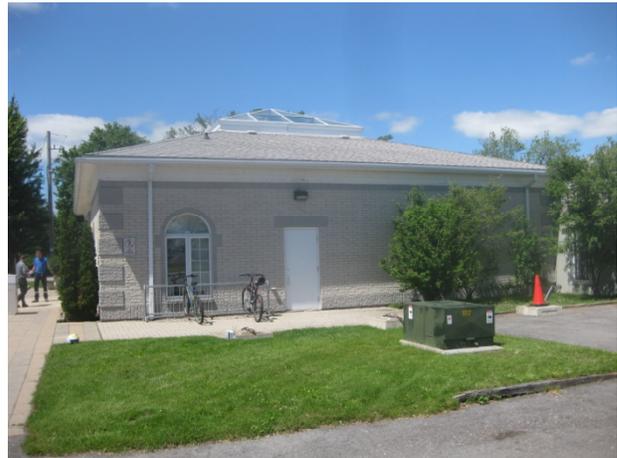
Photo 2 - South elevation (library)

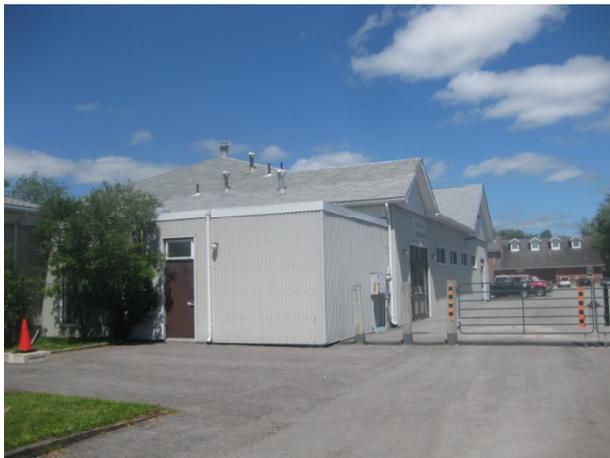
Photo 3 - Southwest elevation

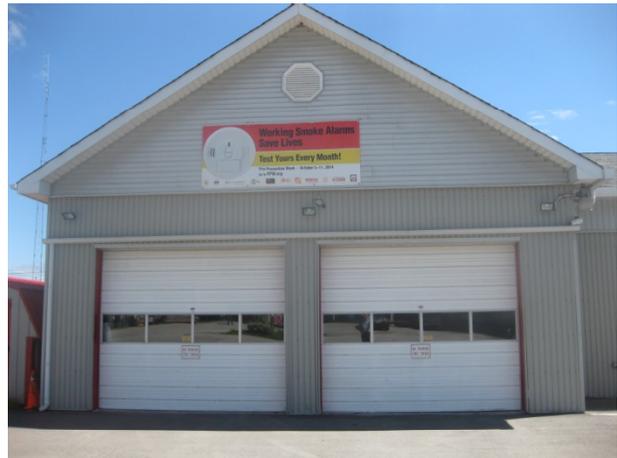
Photo 4 - North elevation (fire station)

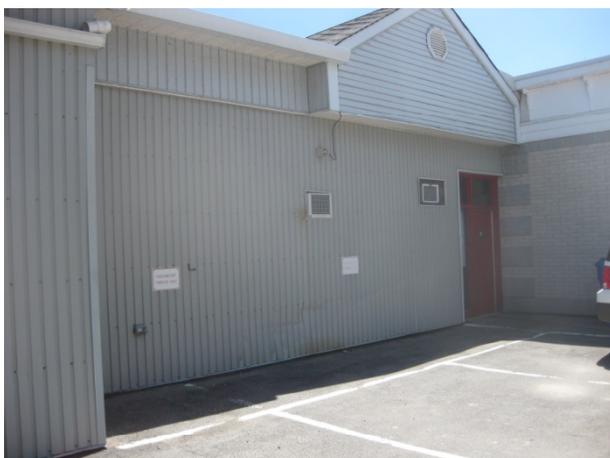
Photo 5 - North elevation (EMS entrance)

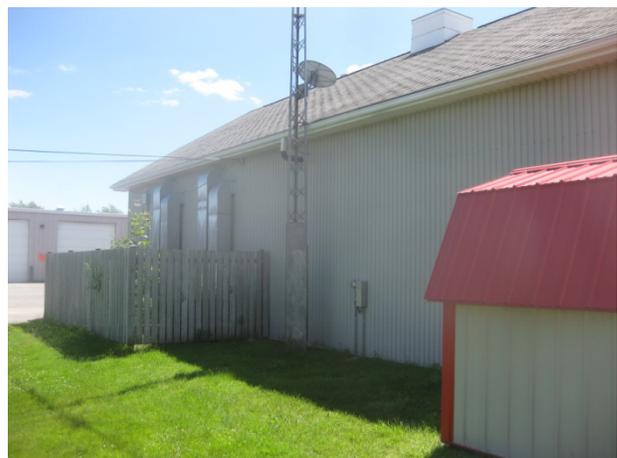
Photo 6 - East elevation (fire station)

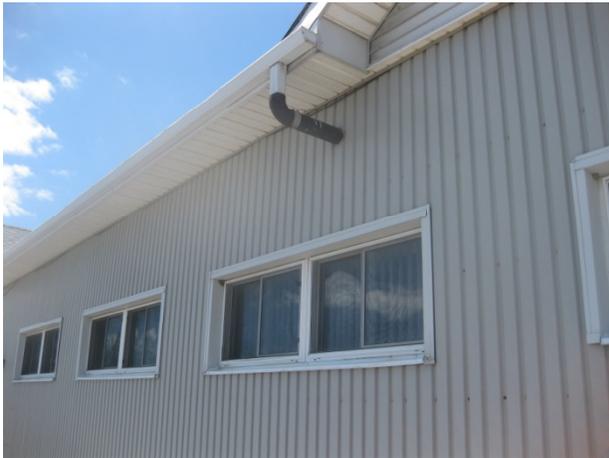
Photo 7 - South downspout (going thru bldg)

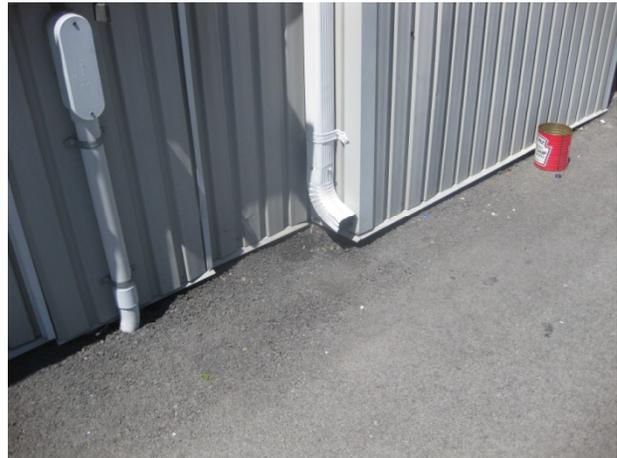
Photo 8 - Short downspout

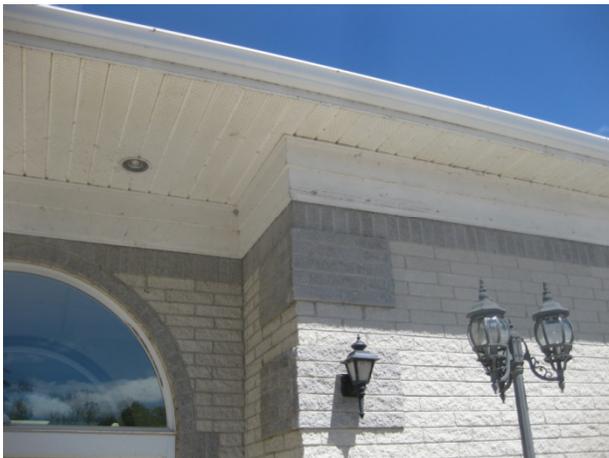
Photo 9 - Typical soffit

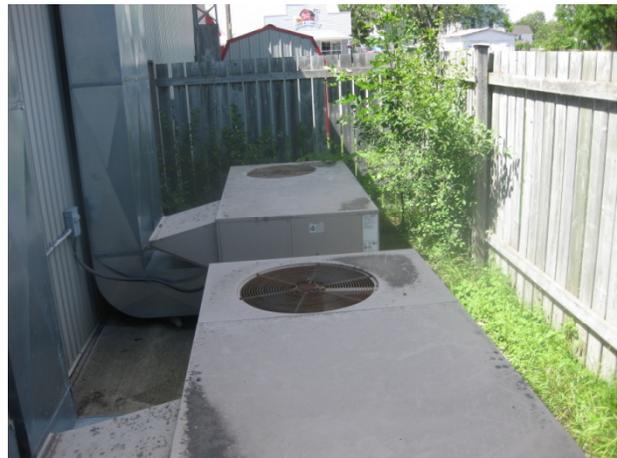
Photo 10 - HVAC units in enclosure

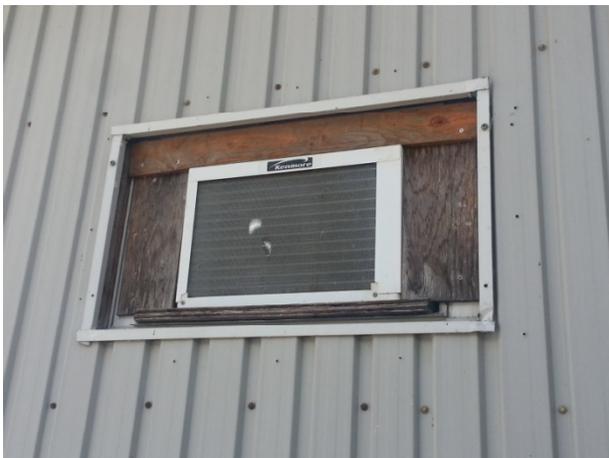
Photo 11 - Window AC for EMS

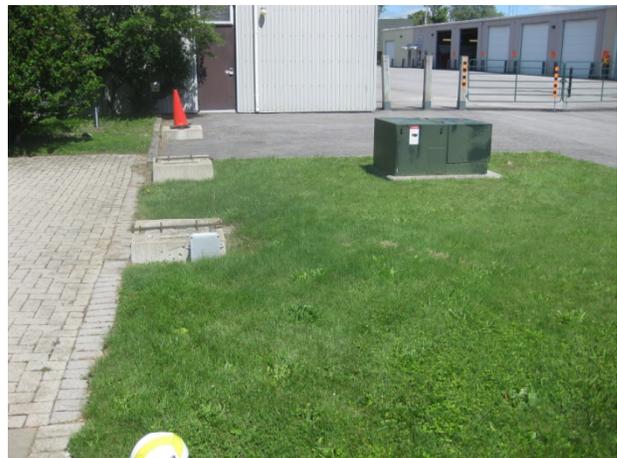
Photo 12 - Transformer and septic

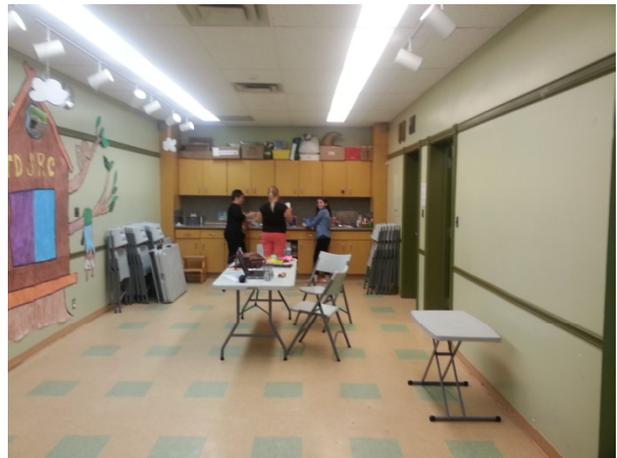
Photo 16 - Library meeting room

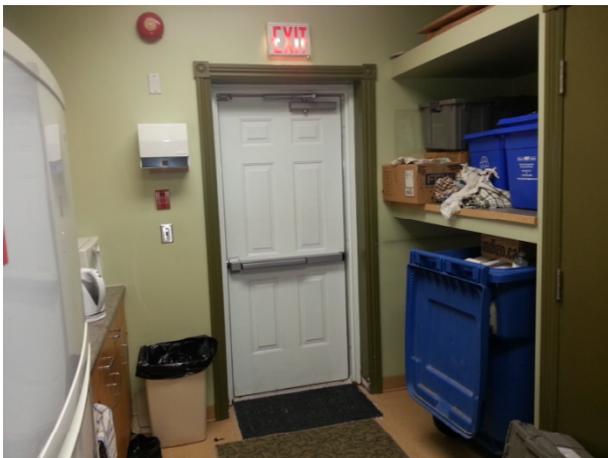
Photo 17 - Meeting room exit door

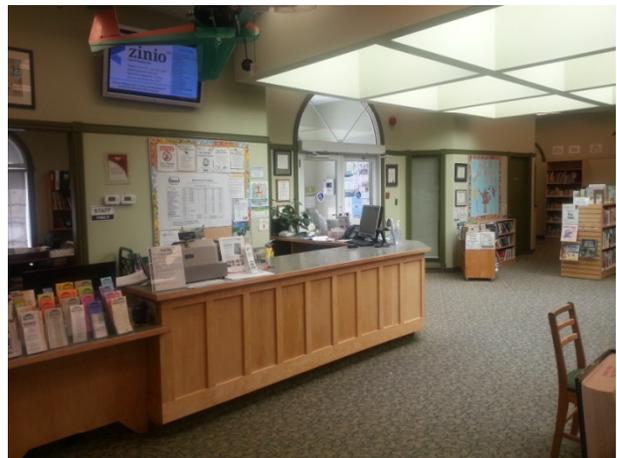
Photo 18 - Library reception desk

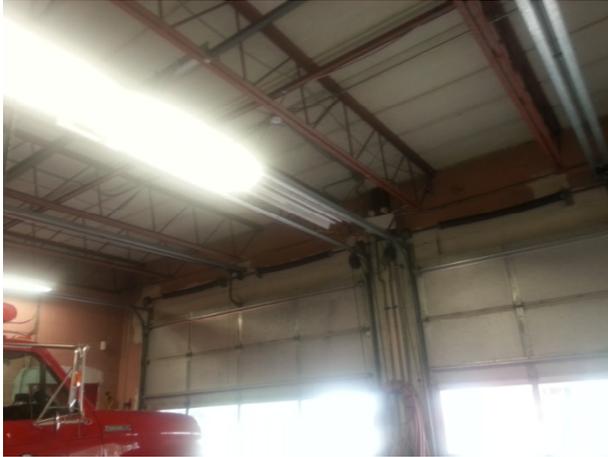
Photo 19 – Fire station structure

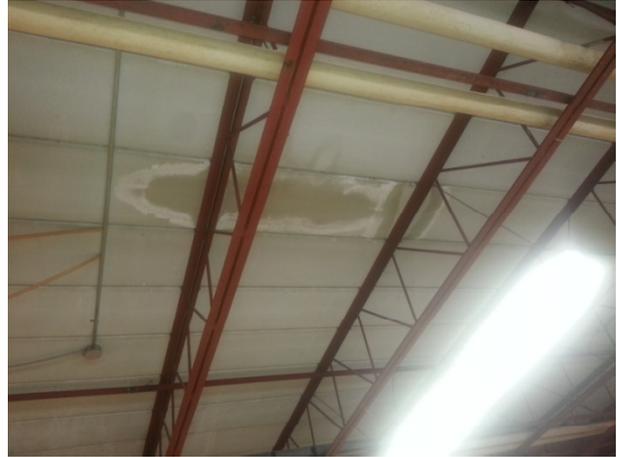
Photo 20 – Fire station roof (Siporex)

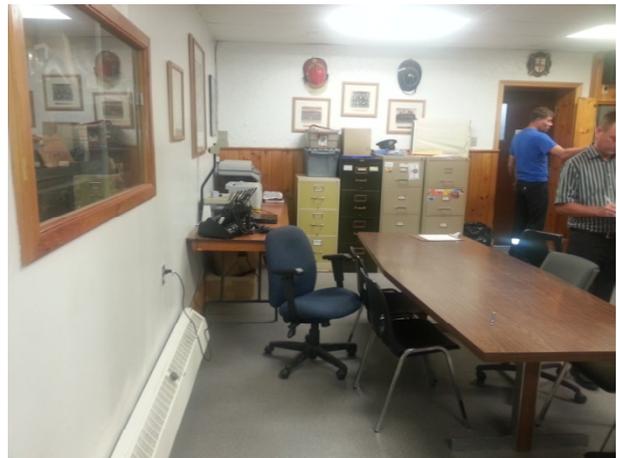
Photo 22 – Fire station meeting room

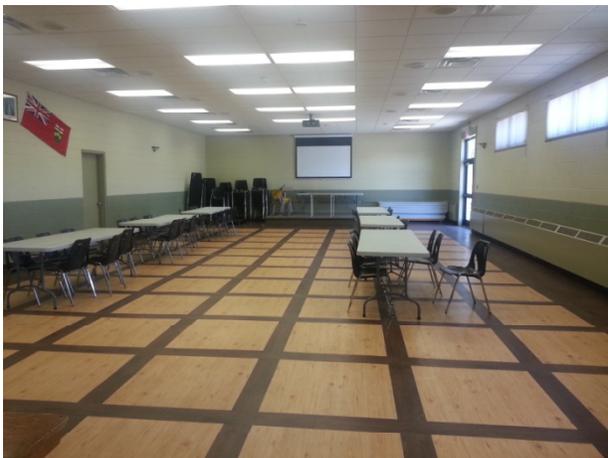
Photo 23 – Community room looking east

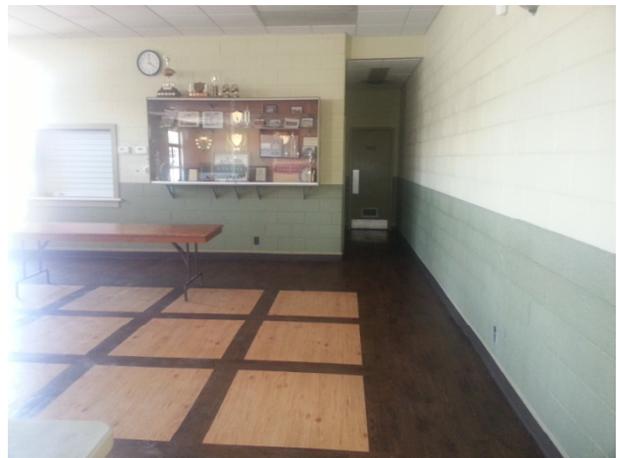
Photo 24 – Community room looking west

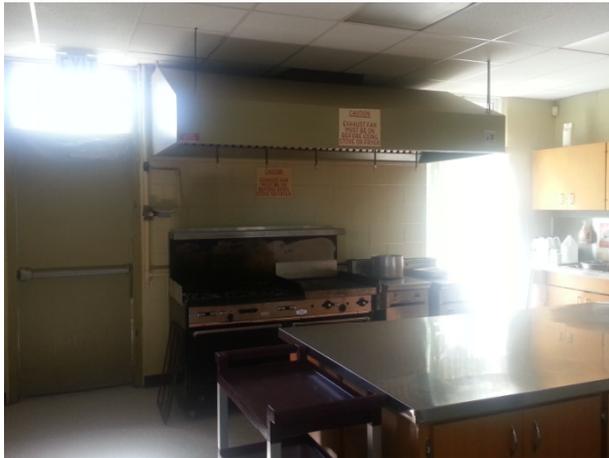
Photo 25 - Community room - kitchen hood

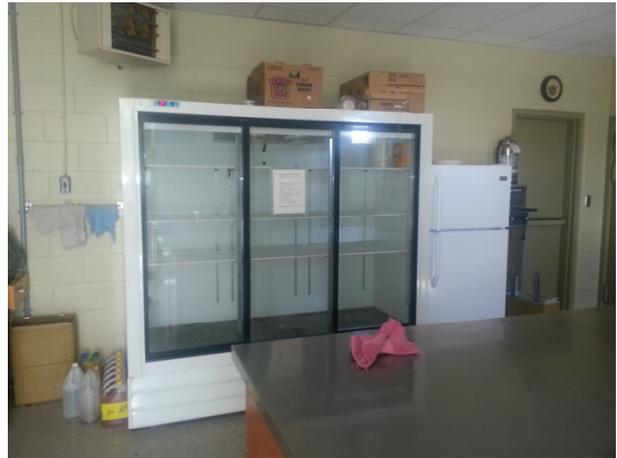
Photo 26 - Community room - kitchen cooler

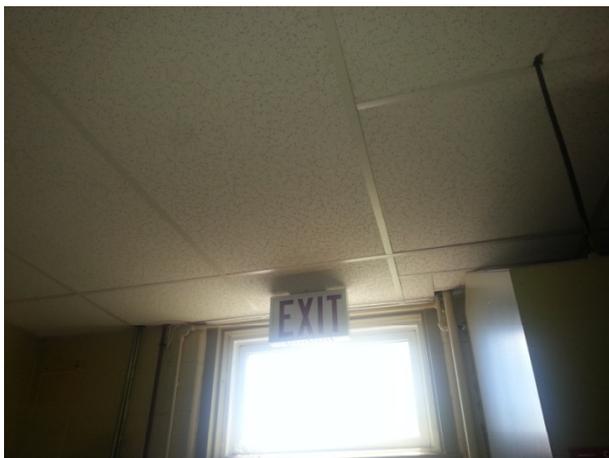
Photo 27 - Exit sign not working

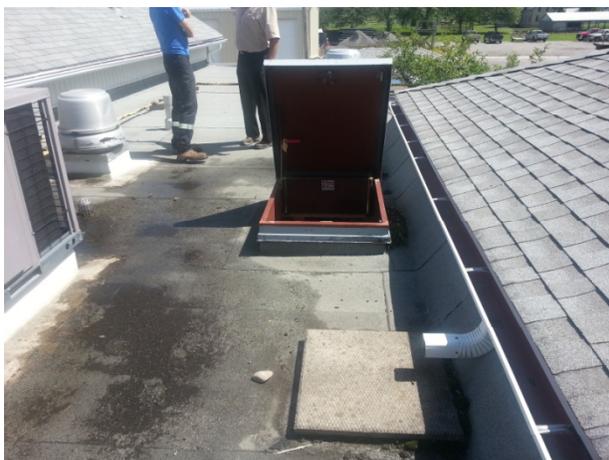
Photo 29 - Roof hatch

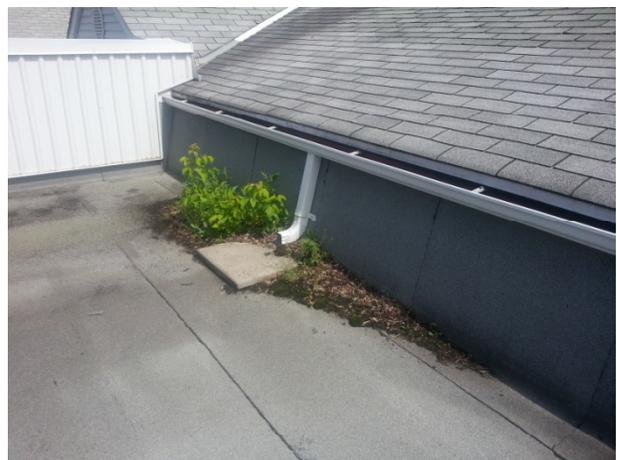
Photo 30 - plant growth on roof

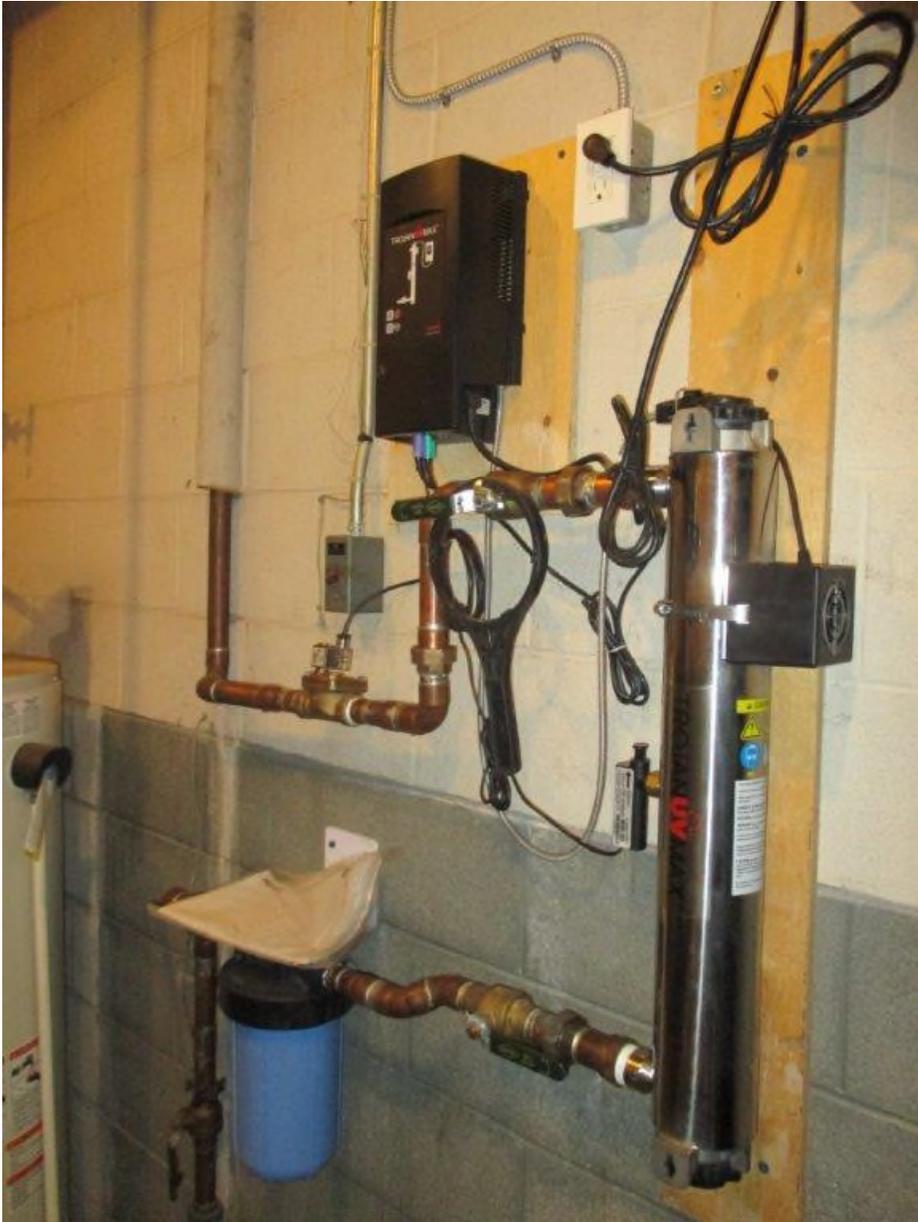
P1 – Water entrance and UV filter

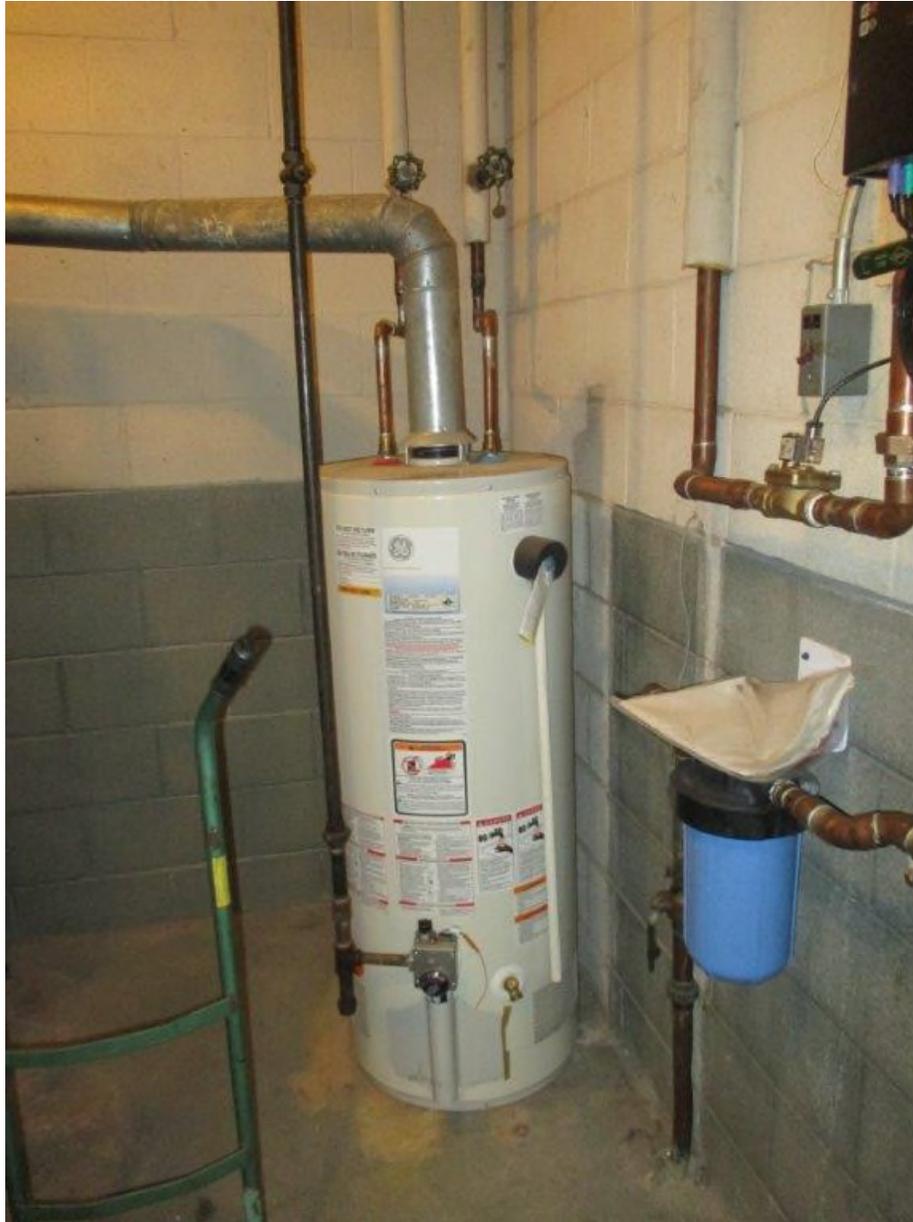
P2 – Uninsulated water piping, water heater

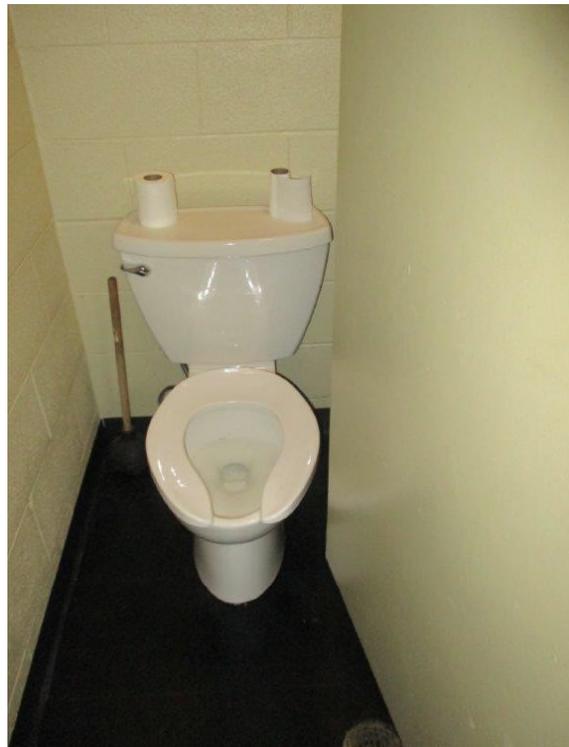
P4 – Plumbing fixtures

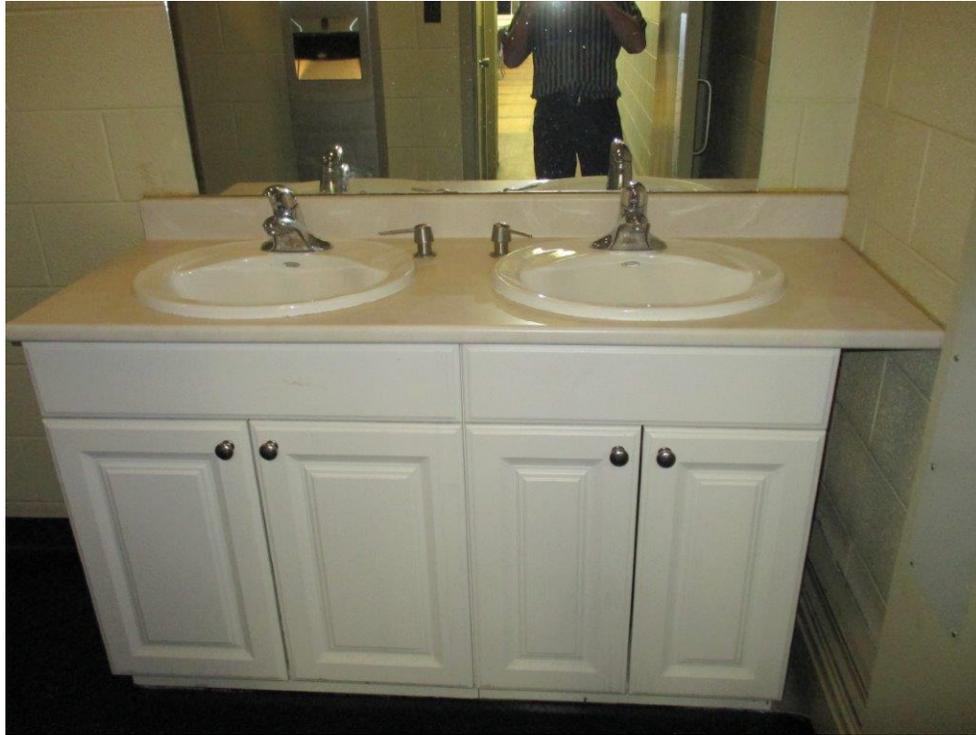
P5 – Plumbing fixtures

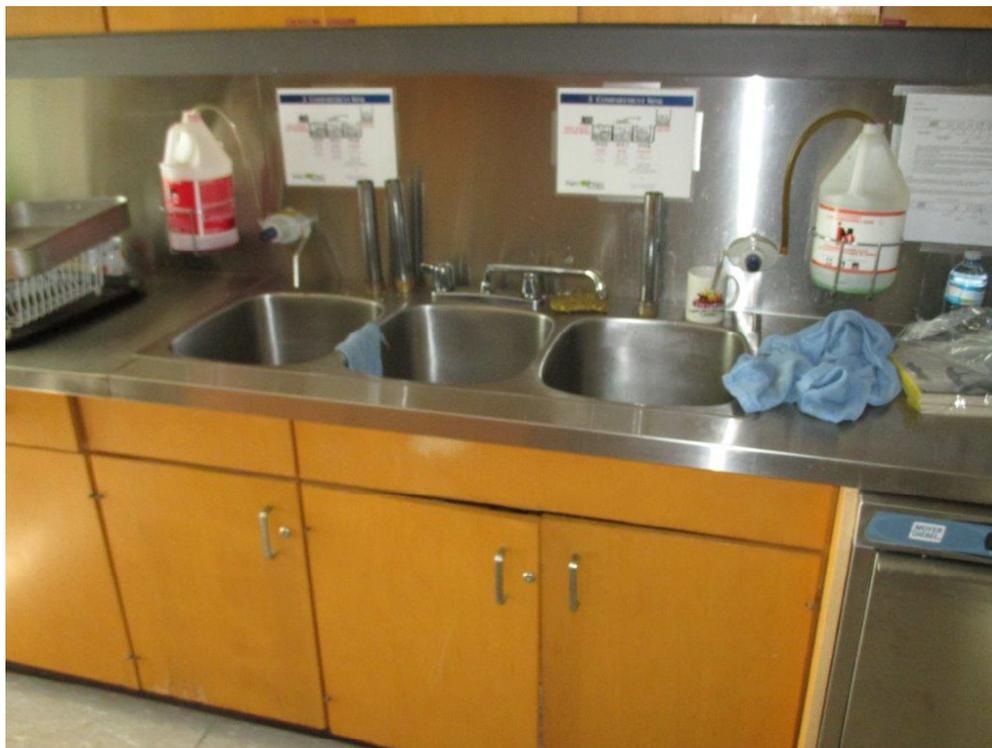
P6 – Plumbing fixtures

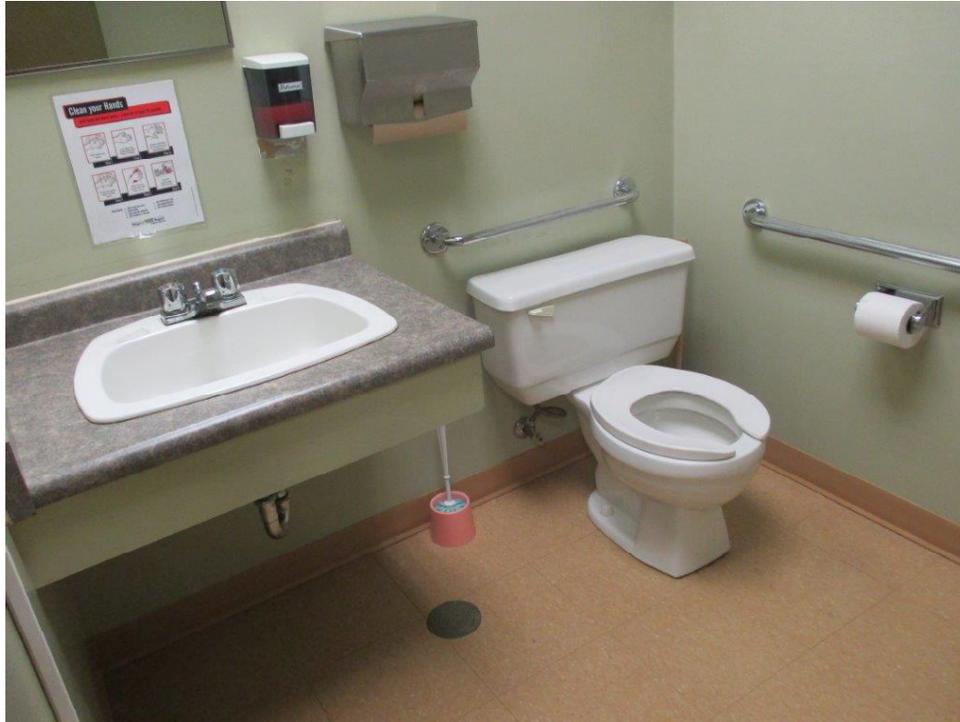
P7 – Plumbing fixtures

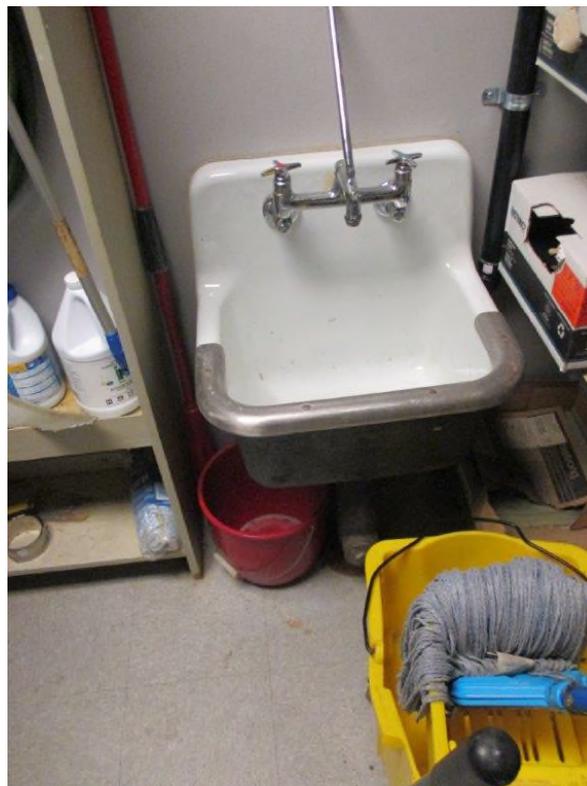
P8 – Plumbing fixtures

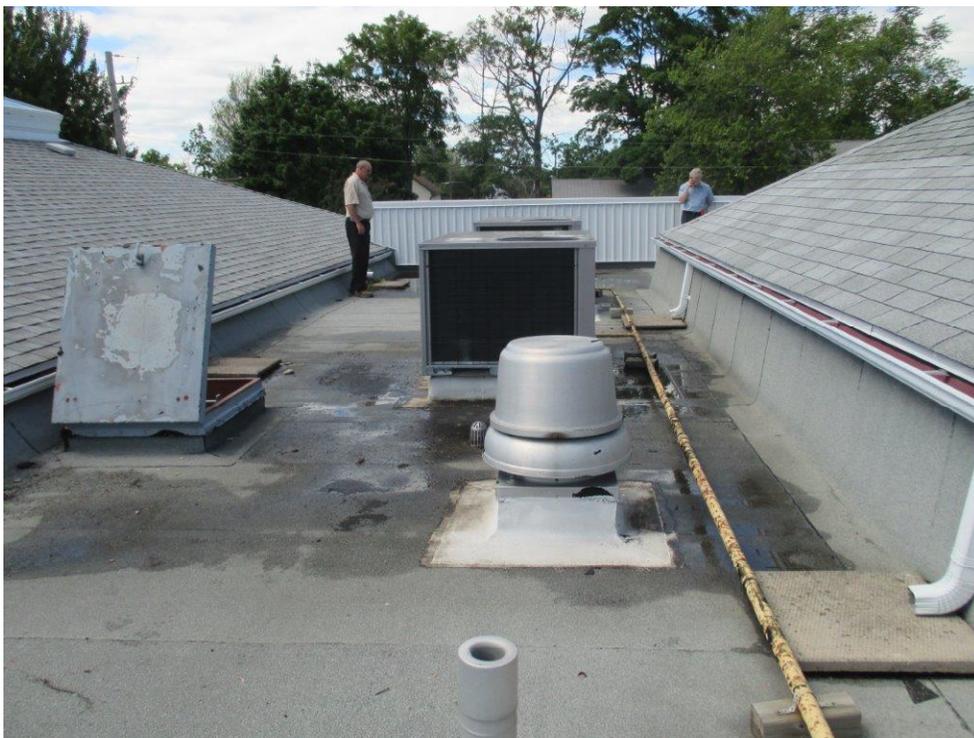
P10 – Flat roof

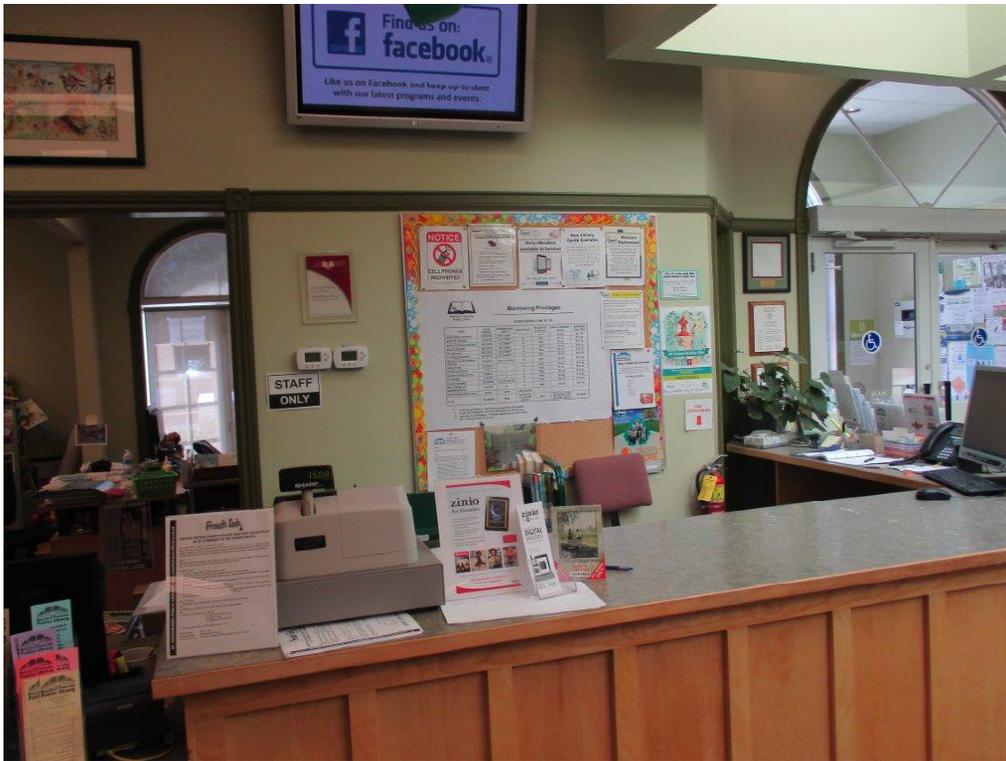
P13 – Library thermostats

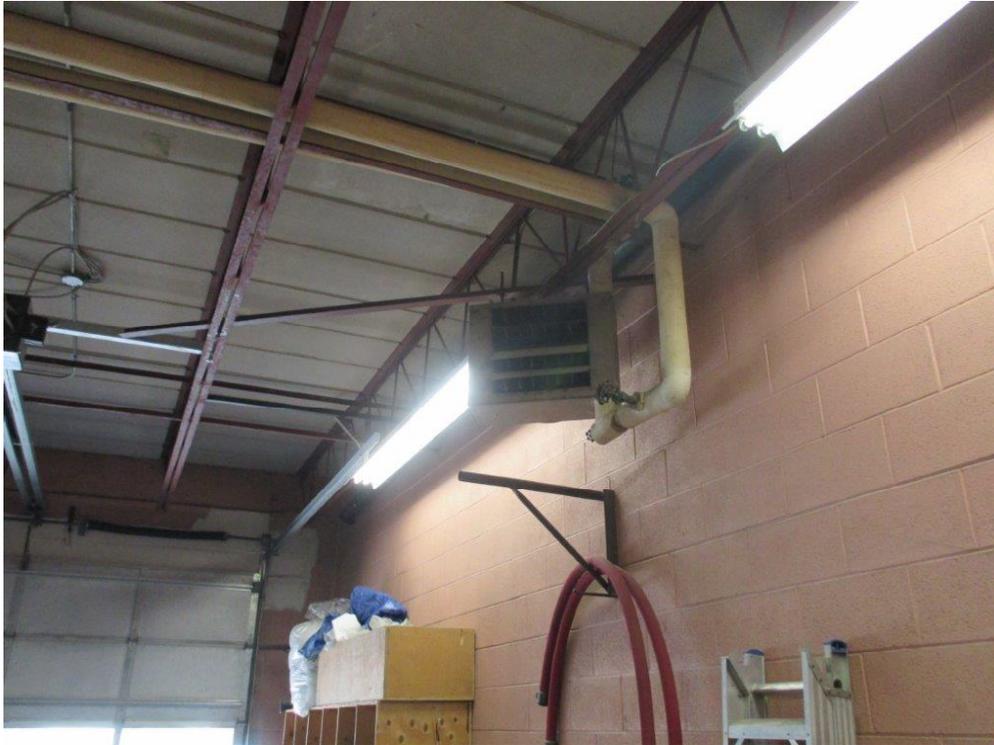
P15 – Fire Hall unit heater

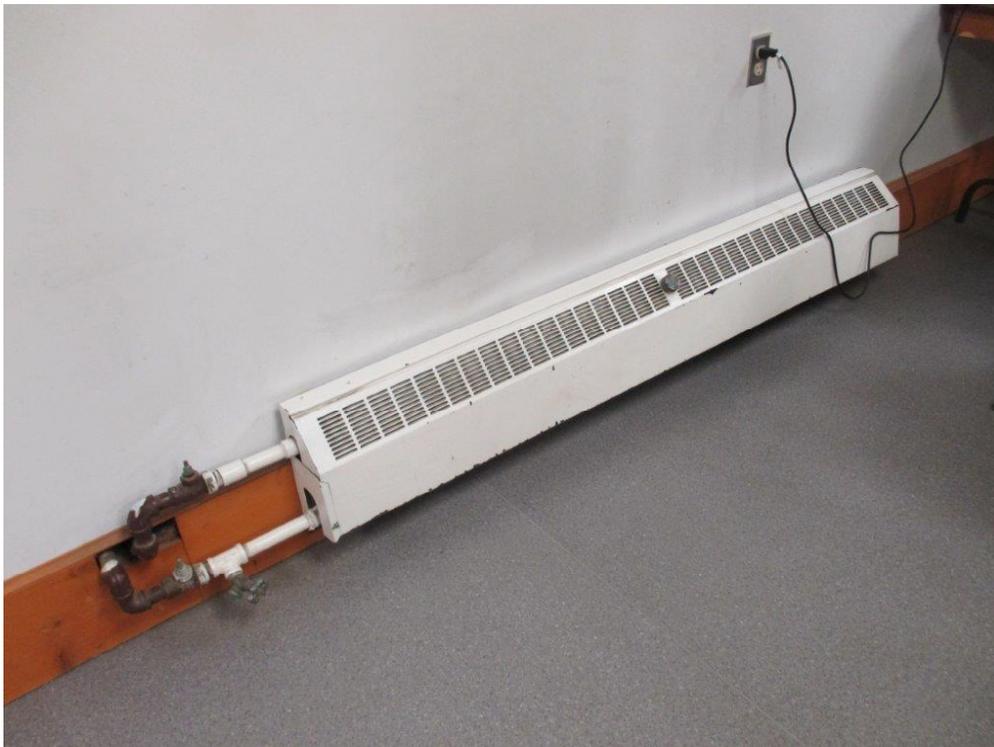
P16 – Lounge hydronic radiation

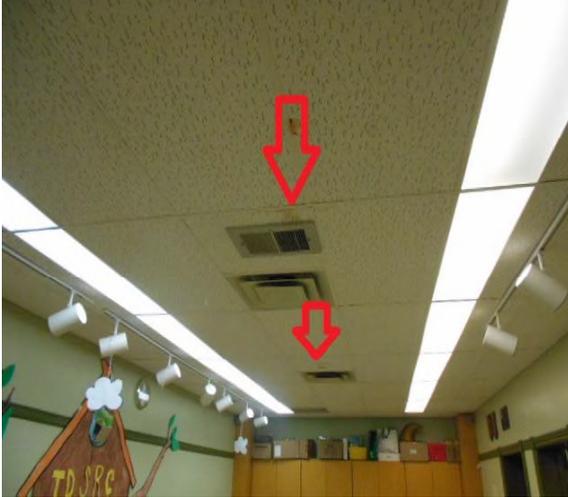
Photo 1

- C.A.B.S. Inc. observed that some ceiling tiles on the interior of the library were wet or damaged due to leakage. (Photo 1 & 2)
- We noted that on the flat roof over the library, which appears to be a 2-ply modified bitumen system, the gravel ballast has been displaced.

Red arrows indicate areas of water leakage in back room and main library.

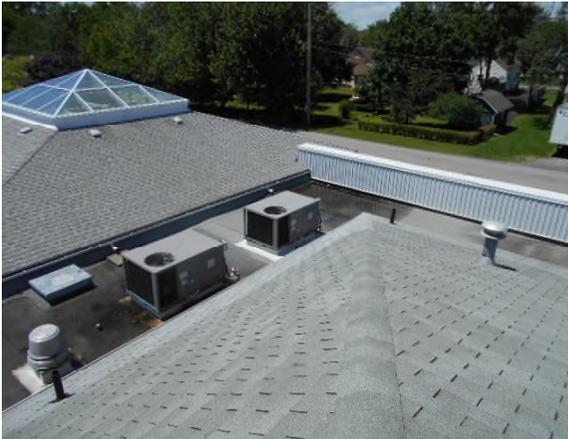
Photo 3

- The screen for the drain, adjacent to the EMS, is missing and the other drain screen appears to be plugged with debris which is causing ponding and inhibiting proper drainage of the roof. (Photo 3)

Drain screen missing from drain on lower roof. Vegetation of roof beside paver.

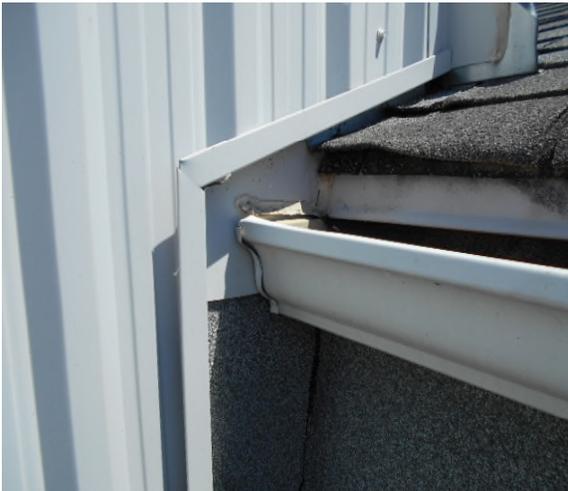
Photo 5

- We noted that the caulking at the end of the evestrough, which marries into the upper parapet wall, has sagged a bit and is separated from the evestrough. (Photo 5)

Sealant is separated from end of eave. Elastomeric coating at curb of unit.

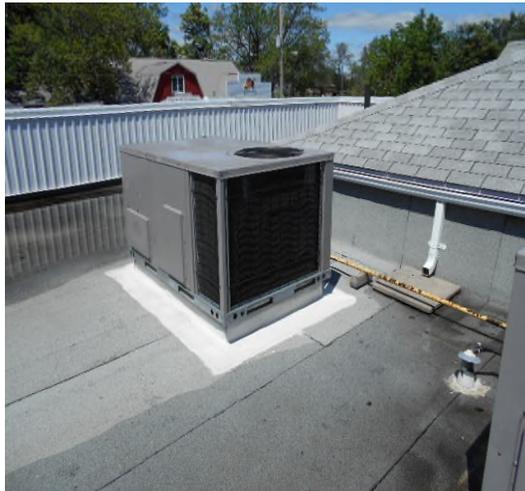
Photo 6

- It was noted that there is a coating with what appears to be mesh embedded in it on the upstands of the curbs as well as onto the deck at the two roof top units, on the flat roof. (Photo 6)

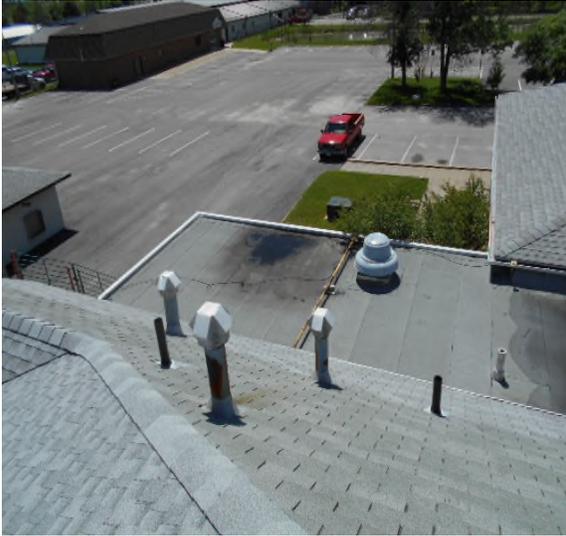
Photo 7

- There is substantial ponding of water around the rooftop unit and the smaller exhaust in from the roof hatch access. (Photo 7 & 8)
- C.A.B.S. Inc. removed some of the maple tree keys that were blocking drainage around the screen for the roof. (Photo 9)

Ponding water was observed at numerous locations on this small roof area.

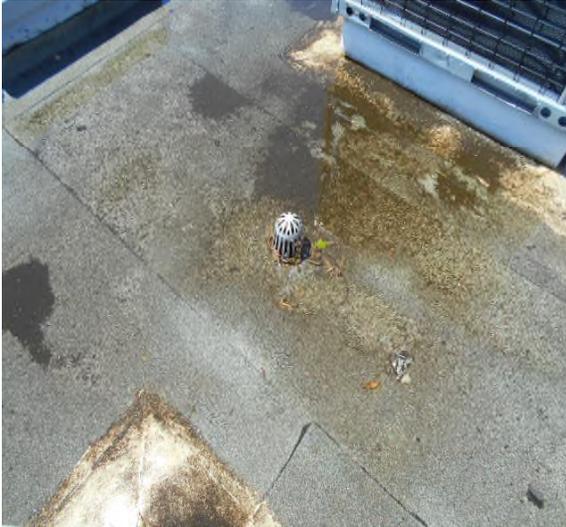
Photo 9

C.A.B.S. Inc. removed Maple keys from around drain screen to allow water to drain. Condensate from roof top unit adds to water ponding.

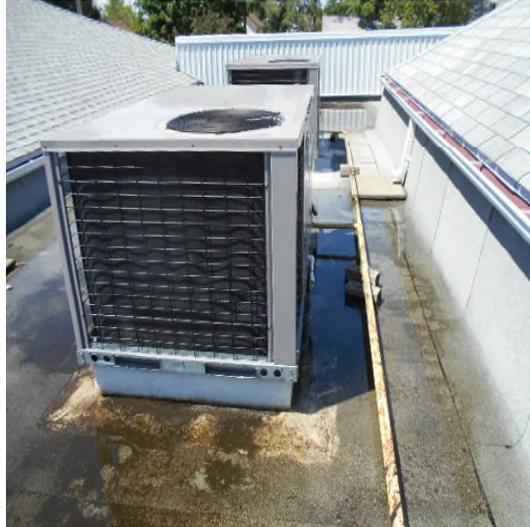
Photo 10

- Another issue was with this roof not being maintained is that there is a constant stream of water coming out through the condensate on the air conditioning unit adding to the volume of water on the roof. (Photo 10)

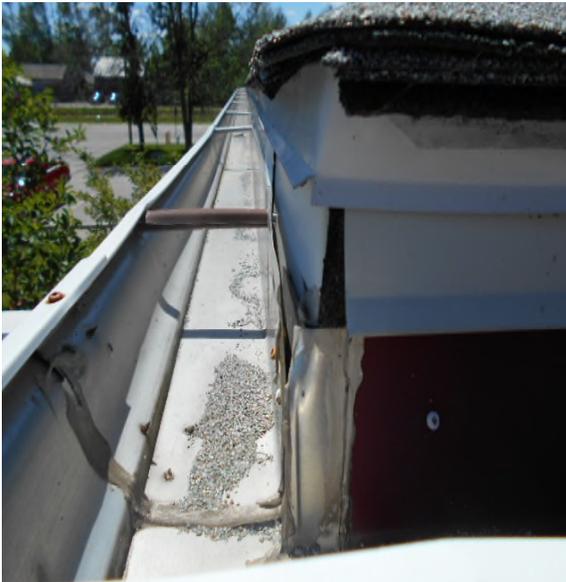
Photo 11

- It was noted that the evestrough for the library roof at the corner, where the light sensor is, is pulling away from the wall and may allow for water to filter in down below. (Photo 11)

Evestrough is pulling away from wall. Membrane seam does not appear to be sealed as there is a lack of bleed out of hot bitumen.

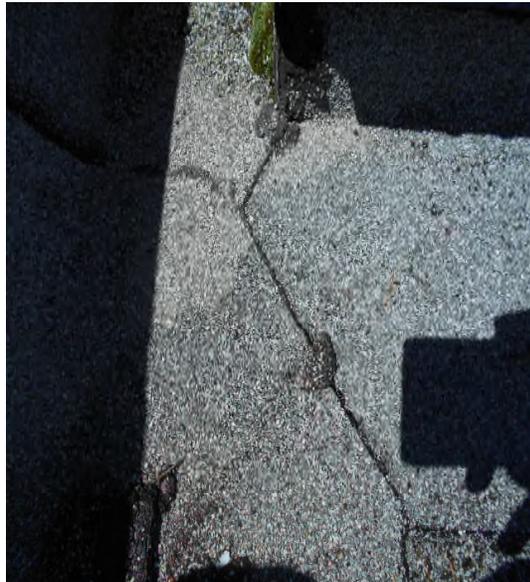
Photo 12

- It appears that at the corner, below the light sensor, the SBS cap sheet membrane at the corner, the membrane underneath had not been degranulated or the granules have not been embedded into the rubber, which can create a source of water ingress. (Photo 12)

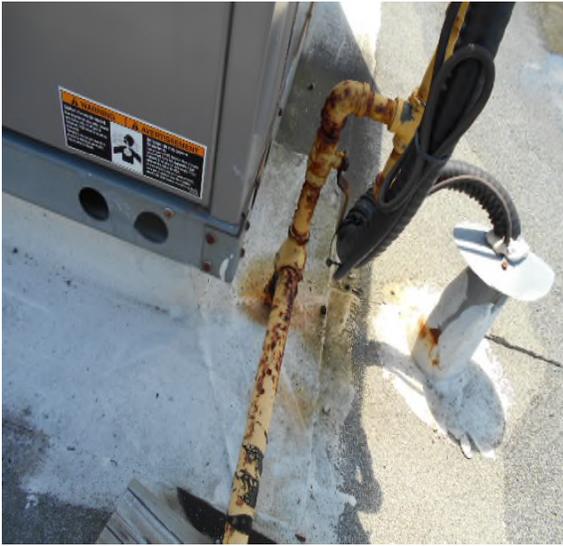
Photo 13

- C.A.B.S Inc. observed that the gas line to the roof top units is rusting. (Photos 13 & 14)
- The proper gum boxes were not used for the electrical services for the rooftop unit and we noted that where the wire protrudes through the caulking at the flex wire there is a substantial hole which would allow for water infiltration. (Photos 15 & 16)

Rusting gas lines can become problematic if not addressed.

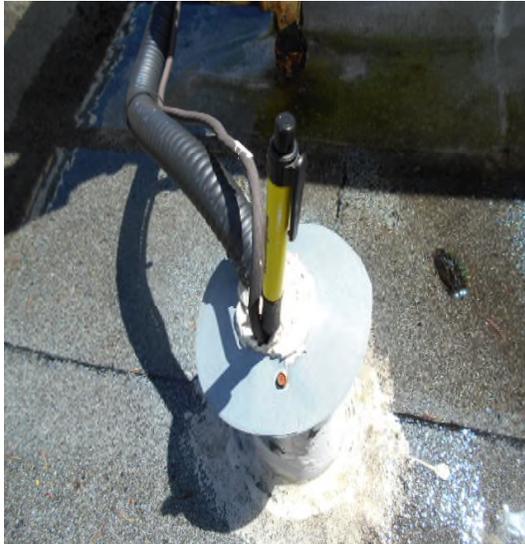
Photo 16

Proper goosenecks should be used at all penetrations. Note the hole at the top where the wire and flex comes through the top of the cone.

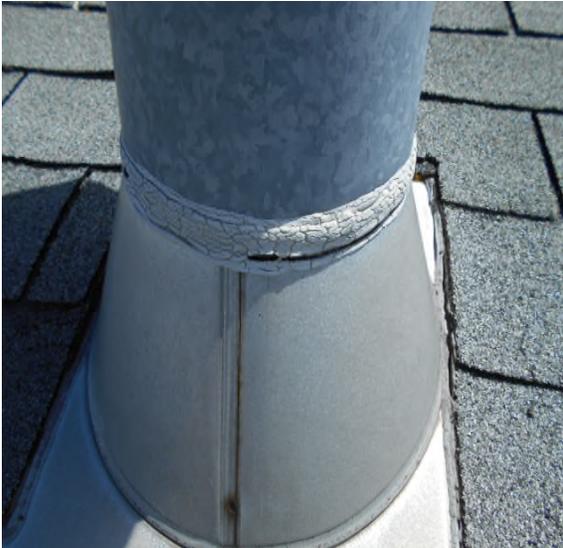
Photo 17

- Sealant on chimney collar is failing. (Photo 17)
- We were advised, by library staff that in the back room there was water near a diffuser which could account for this leakage.

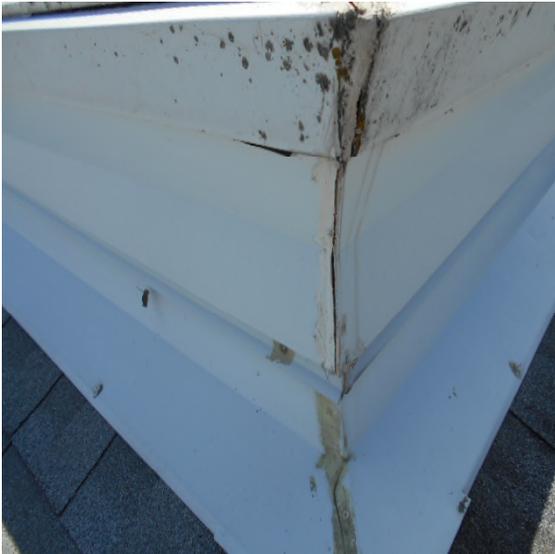
Photo 1

- The metal flashing seals on the corners of the skylight have failed and could allow a wind driven rain access into and behind the roof assembly.
- C.A.B.S Inc. noted that the sealant on the skylight has sheared from the flashing to the cap flashing on the skylight. (Photos 1 – 3)

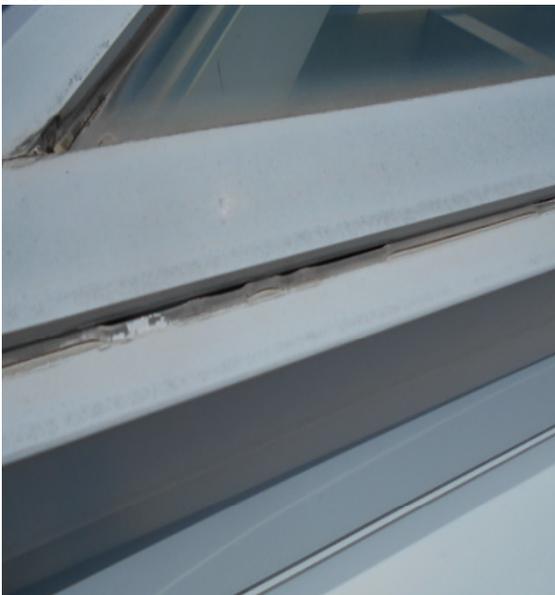
Photo 3

Sealant on flashings of skylight is failing at corner. Sealant also inconsistent on skylight units.

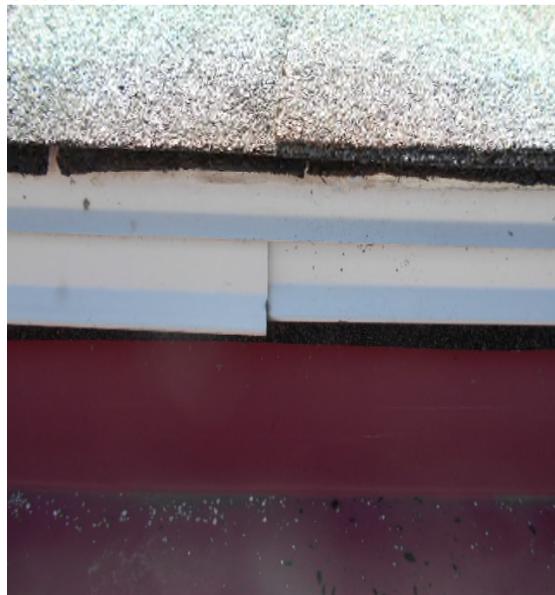
Photo 4

- C.A.B.S Inc. observed that the counter flashing coming from underneath the skylight flashing is not sealed and is away from the connection.
- There is what appears to be a gravel stop at the base of the shingles and it appears that a roofing felt comes from the gravel stop but how far up the felt goes under the shingles we are unsure. (Photo 4)

Caulking shearing at top of flashings. Connection of gravel stop questionable.

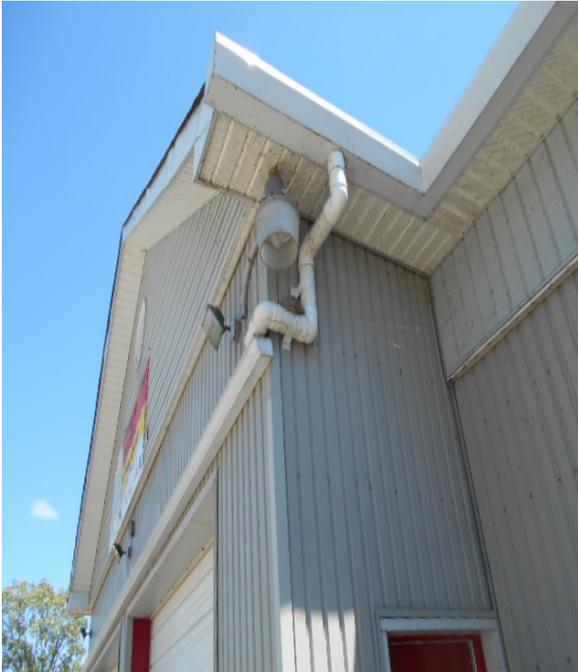
Photo 1

- C.A.B.S Inc. observed that the evestrough on the upper portion is a commercial evestrough and the PVC piping is distributing the rain water to a residential evestrough immediately above the overhead door which discharges through a downspout that terminates down the side of the storage shed. (Photo 1)

Upper commercial eavestrough drains through PVC pipe into residential trough above overhead doors. Shingles have been bent at eaves and are cracking.

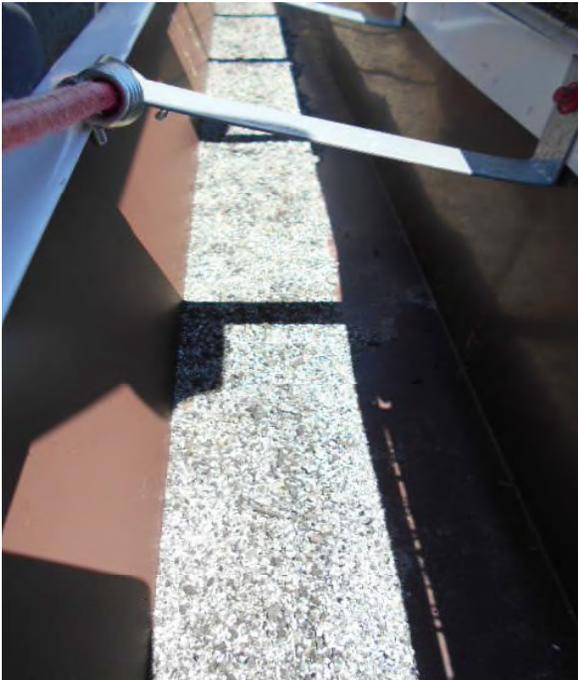
Photo 3

- C.A.B.S Inc. observed that the granules from the shingles were washed into the eavestrough. (Photo 3)
- In the area above the EMS, the edges of the shingles are curling and some cracking of the shingles was observed. (Photo 4 & 5)

Granules from shingles are seen in eavestrough. Corners of shingles are curling indicating fatigue.

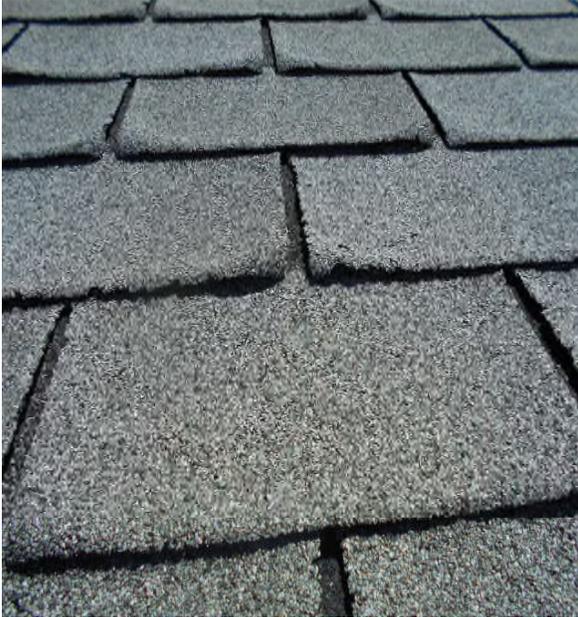
Photo 5

Close up of curling shingles. Flashing for chimneys stacks is lifting and a wind driven rain will allow water penetration to the interior.

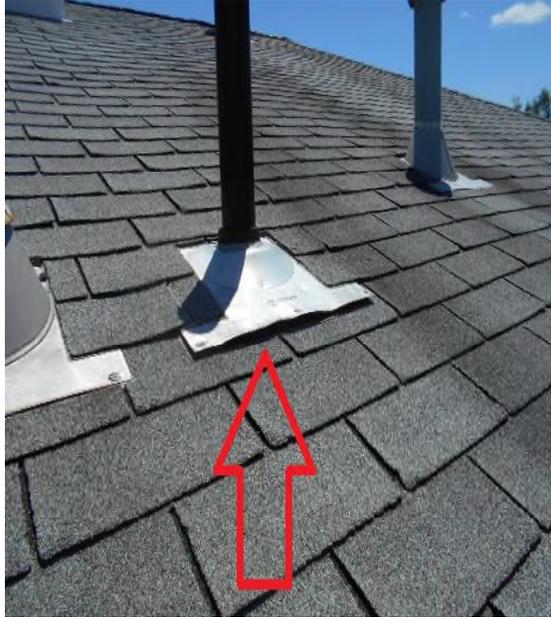
Photo 6

- It was noted that the bottom of the flange for one of the vent stacks is lifting. (Photo 6)
- It appears that the shingles on the backside of the building have been recently replaced.
