Wainfleet Library and Fire Station No. 2

Condition Assessment – 2015

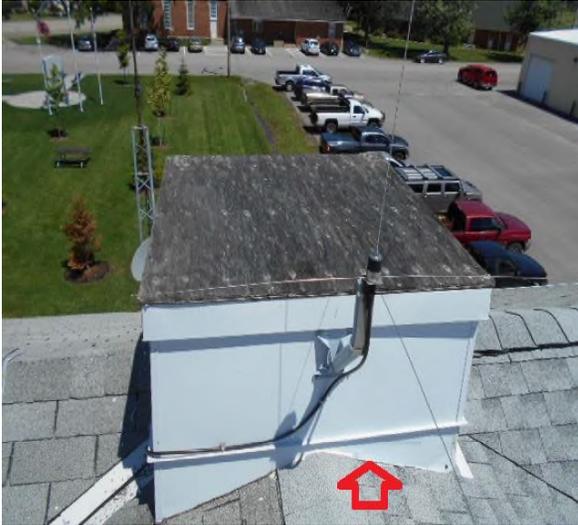
Photo 7

- C.A.B.S Inc. observed that at the top of the roof, where the antenna is, there is a piece of exposed plywood which is delaminating and should be capped at a minimum. (Photo 7)

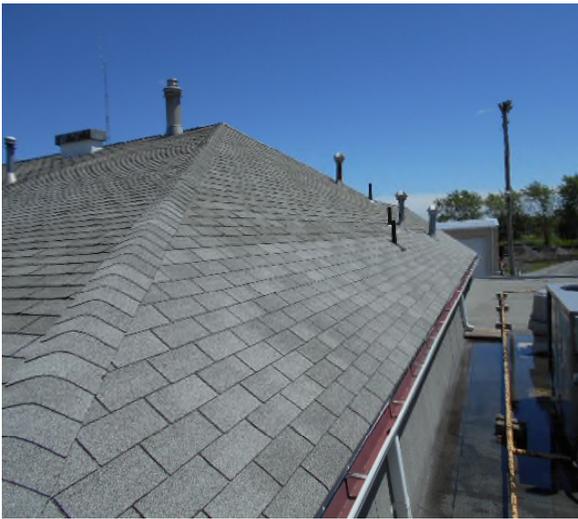
Photo 13

- The lower portion of the EMS roof has been reshingled adjacent to the library flat roof. (Photos 11 & 13)
- C.A.B.S Inc. observed that on the lower portion of the new shingled area, the edge of the metal flange for the vent stack is lifting and causing the shingle to lift as well. The flange is rusting indicating that the nail used may not be compatible with the metal flange. Shingles at ridge are lifting. (Photo 12)

The lower portion of the roof has been resingled. Edge of rubber flange is curling

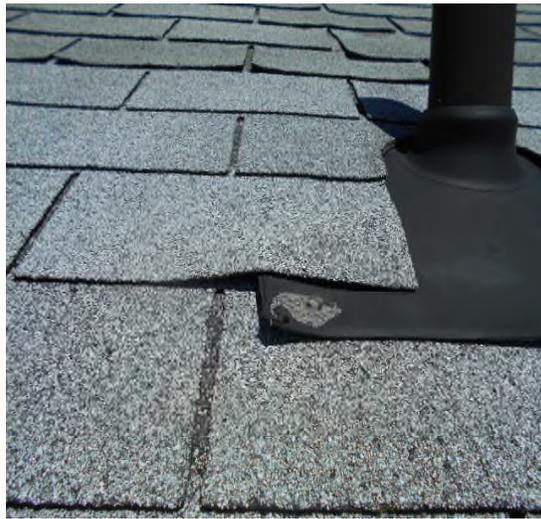
Photo 14

- At the location where the rubber flange for one of the vent stacks above the EMS the shingles are bent up and a wind driven rain could allow moisture penetration. (Photo 14)
- We observed a several holes through the shingles just below the chimney on the EMS and the metal flashings are not secured where in a wind driven situation the water could conceivably get in and leak inside.
- Substantial corrosion to the chimney pipes. (Photo 15)
- C.A.B.S Inc. noted that one of the shingles above the vent stack has become dislodged. (Photo 16)
